Proj. No: 123381.E01
Graphic By: G. GOMEZ
Graphic Date: 12/18/12
Checked By: D.H.
File Name:STO12D138.fh11

SITE PHOTOGRAPHS
1880 DANIELS STREET
APN 222-25-06
MANTECA, CALIFORNIA

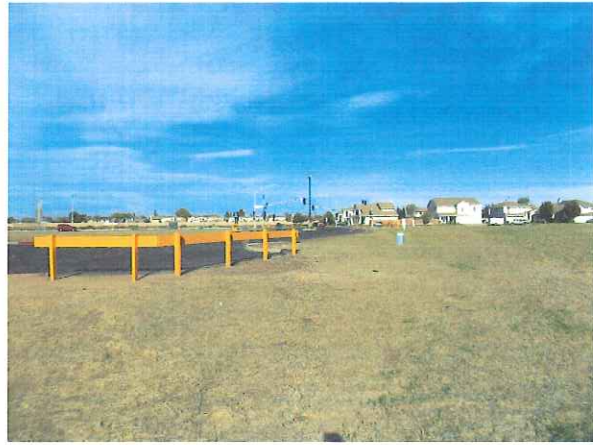
PHOTO 1: Looking north at asphalt entrance along western property boundary.

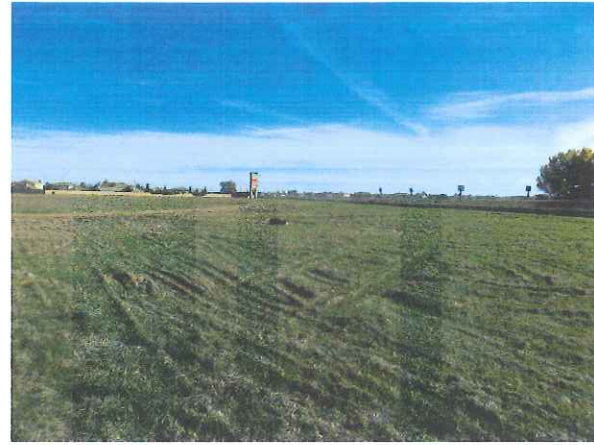
PHOTO 2: View looking southeast over property from west-boundary.

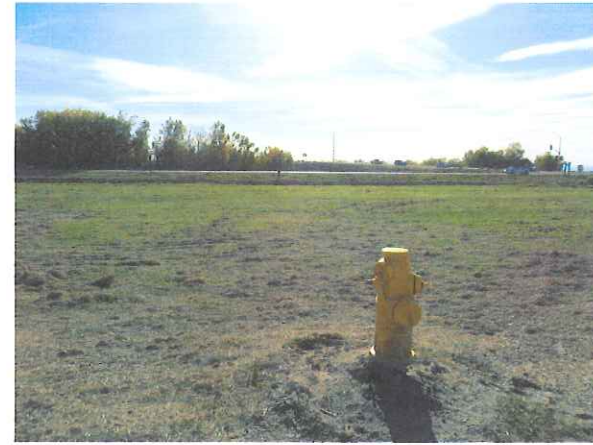
PHOTO 3: Looking south from west-central boundary of the site.

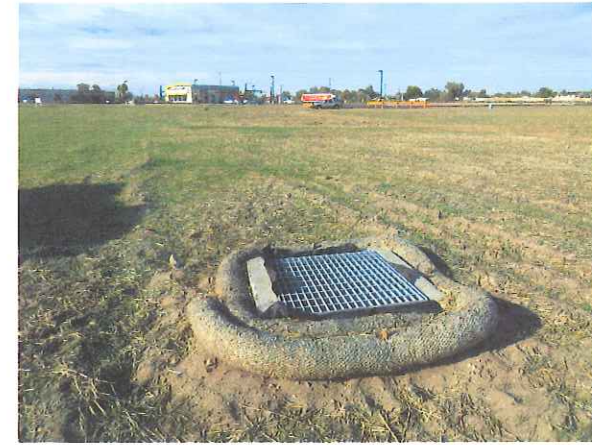
PHOTO 4: One of several utility drainage vaults noted at the site.

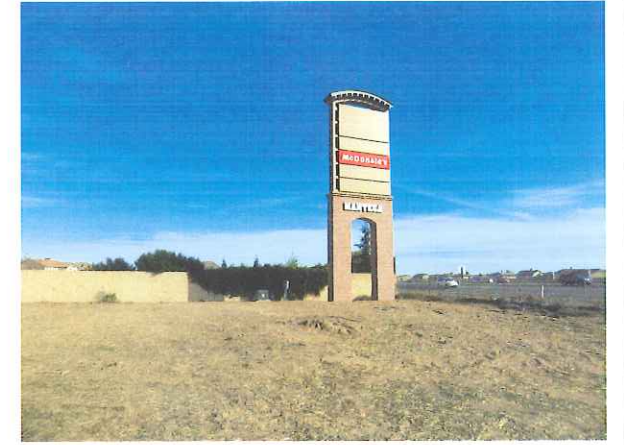
PHOTO 5: Sign and associated electrical panel and pad-mounted transformer in southeast corner of the site.

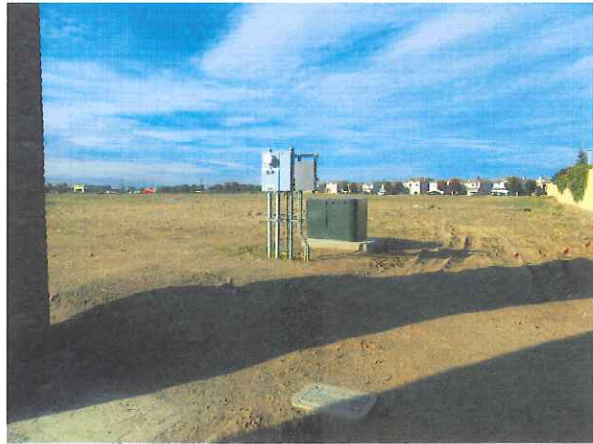
PHOTO 6: Close-up of electrical panel and pad-mounted transformer associated with large sign noted in photograph 5.

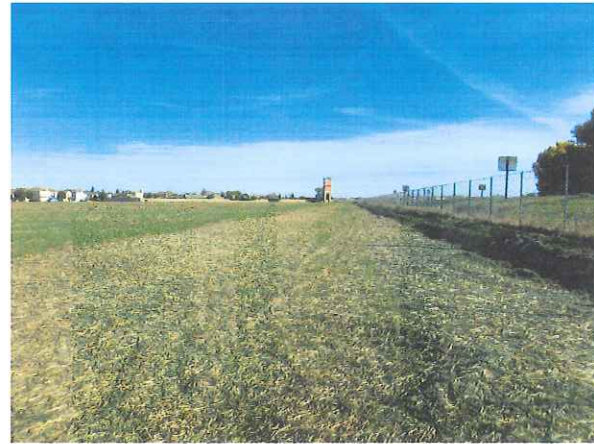
PHOTO 7: Looking east from southwest corner of site. Note low lying area and storm water pollution controls (seeding and straw).

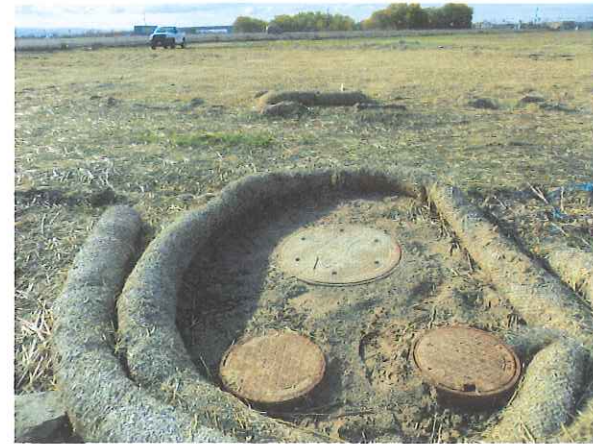
PHOTO 8: Storm drain filtration unit cover noted near southeast corner of the site.

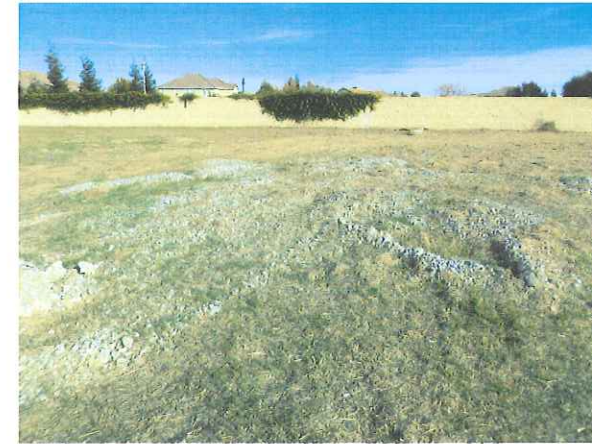
PHOTO 9: Gravel and concrete debris noted within southeast portion of the site.

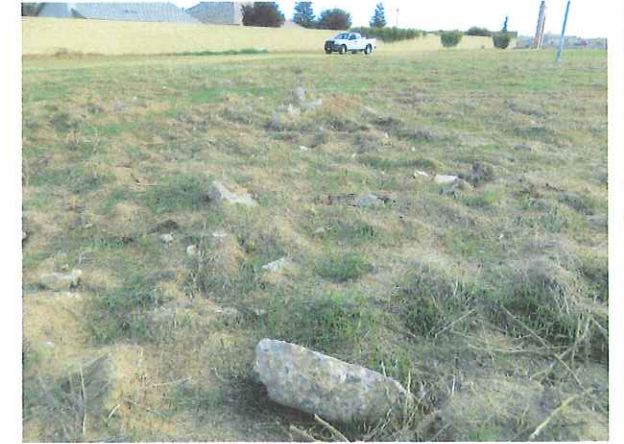
PHOTO 10: Miscellaneous concrete debris and uneven ground in northeastern portion of site.

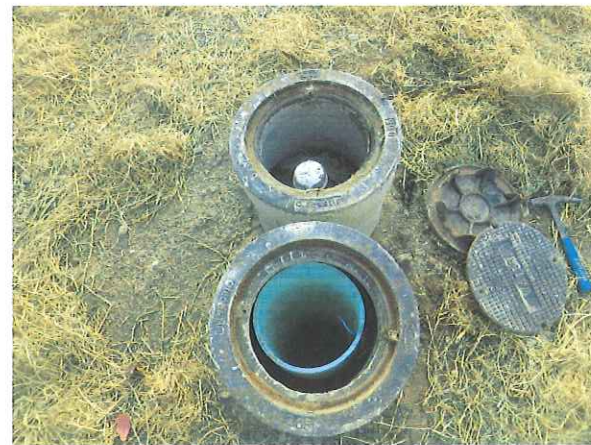
PHOTO 11: Utility vault boxes of electrical and water/sewer.

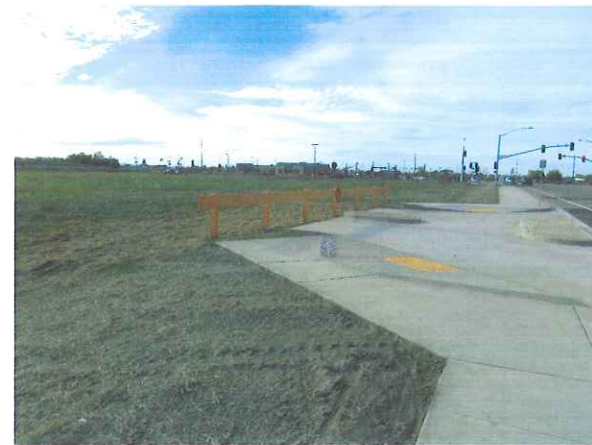
PHOTO 12: One of two concrete entrance driveways noted along the northern property boundary.

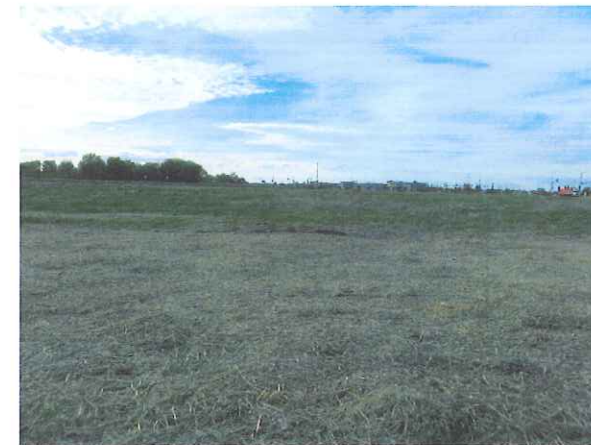
PHOTO 13: View looking southwest over the site from the northeast corner.

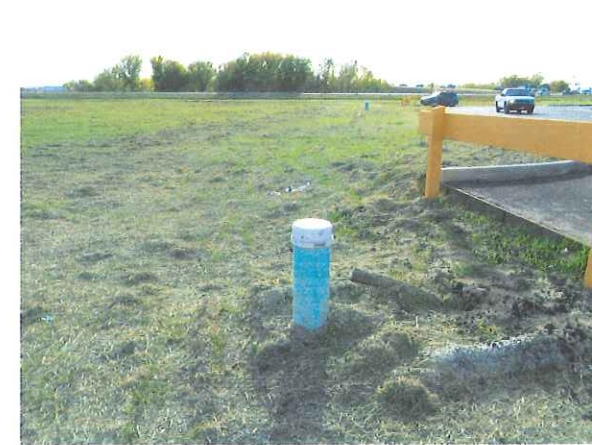
PHOTO 14: View of stubbed sanitary sewer casing along the site western boundary.
