Video → Inspection Specialists

C.C.T.V. INSPECTION OF
IRRIGATION LINE IN MANTECA

DVD #1
2/25/13

CITY OF MANTECA
WASTEWATER QUALITY CONTROL FACILITY

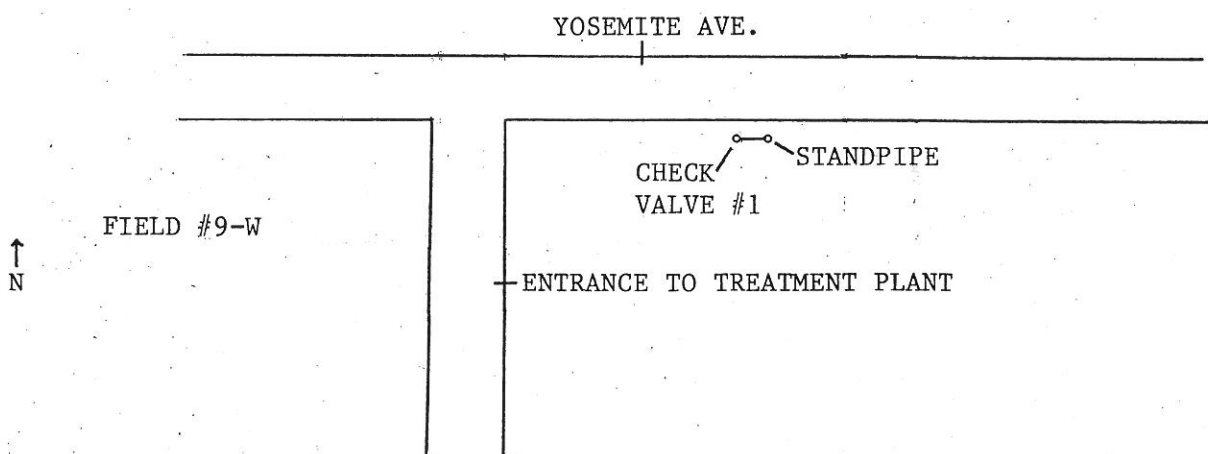
SHEET #: 1

LOCATION OF LINE: HEADING EAST ALONG THE SOUTH SIDE OF YOSEMITE AVE. JUST WEST OF STANDPIPE

FOOTAGE	FRAME	OBSERVATION
4	00:00	START RUN AT CHECK VALVE #1
8	01:50	END RUN - TRACTOR CANNOT GET PAST HEAVY SAND IN THE LINE

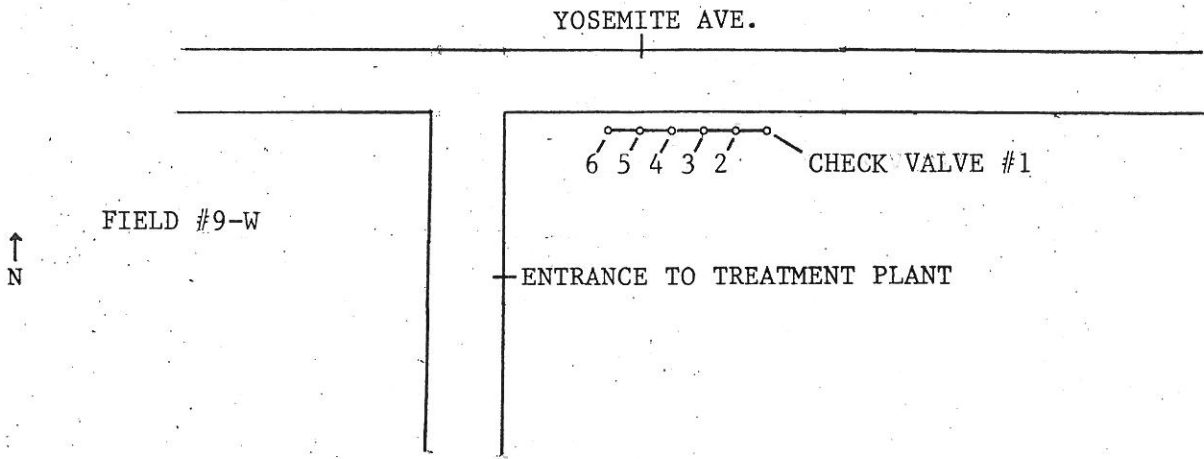
SHEET #: 2

LOCATION OF LINE: HEADING WEST ALONG THE SOUTH SIDE OF YOSEMITE AVE.

<u>FOOTAGE</u>	<u>FRAME</u>	<u>OBSERVATION</u>
4	00:00	START RUN AT CHECK VALVE #1
39	02:20	EXTRA CONCRETE ON LEFT SIDE
50	02:55	CHECK VALVE #2
101	05:40	CHECK VALVE #3

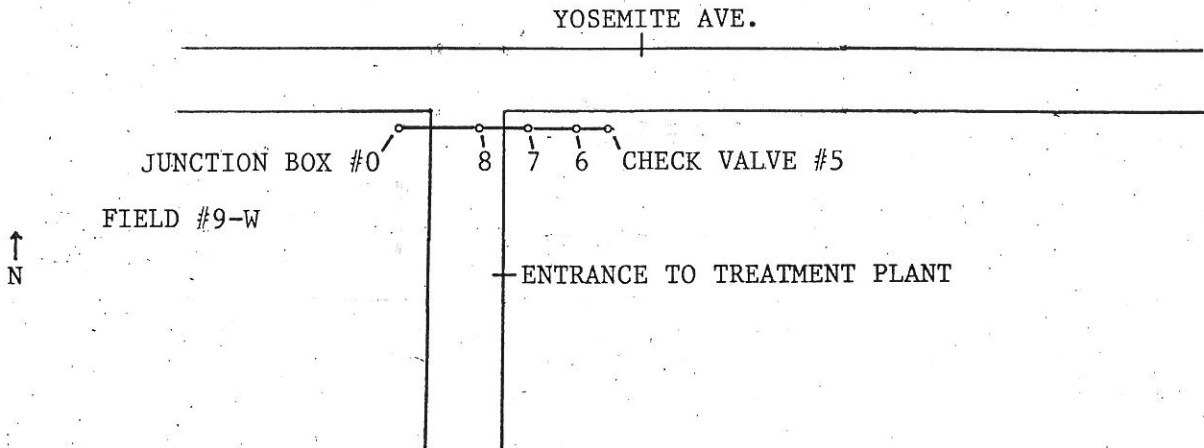
SHEET #: 4

LOCATION OF LINE: HEADING WEST ALONG THE SOUTH SIDE OF YOSEMITE AVE.

NOTES: MISSED ONE CHECK VALVE WHILE CAMERA WAS UNDER THE FLOW

<u>FOOTAGE</u>	<u>FRAME</u>	<u>OBSERVATION</u>
4	00:00	START RUN AT CHECK VALVE #5
4	00:35	START SAG - CONTINUED FROM THE PREVIOUS RUN
34	01:35	CAMERA UNDER THE FLOW
43	02:05	CAMERA ABOVE THE FLOW

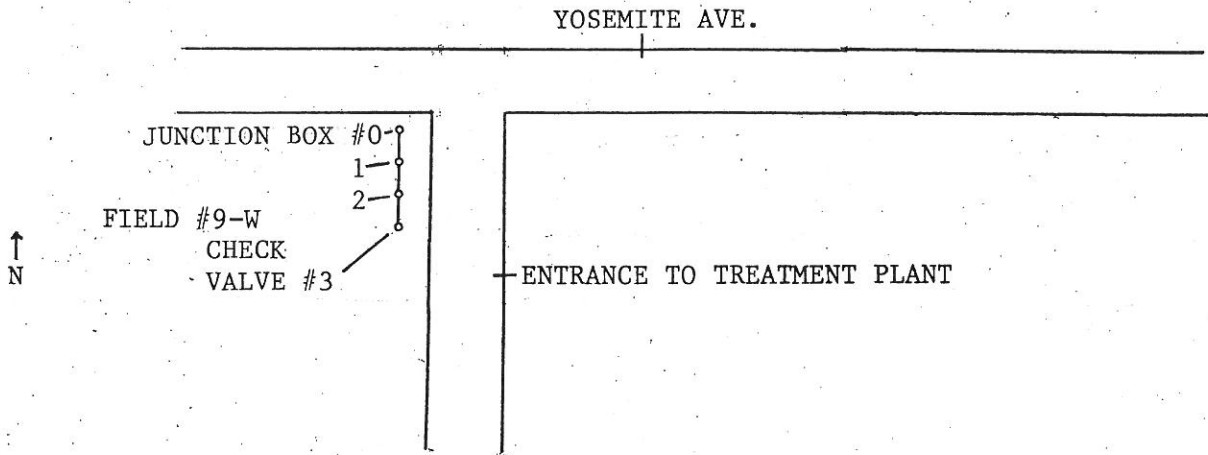
SHEET #: 6

LOCATION OF LINE: HEADING NORTH ALONG THE WEST SIDE OF THE ENTRANCE ROAD TO TREATMENT PLANT

<u>FOOTAGE</u>	<u>FRAME</u>	<u>OBSERVATION</u>
4	00:00	START RUN AT CHECK VALVE #3
32	01:25	RADIAL CRACK IN THE PIPE
43	02:25	START SAG
48	02:30	CAMERA UNDER THE FLOW

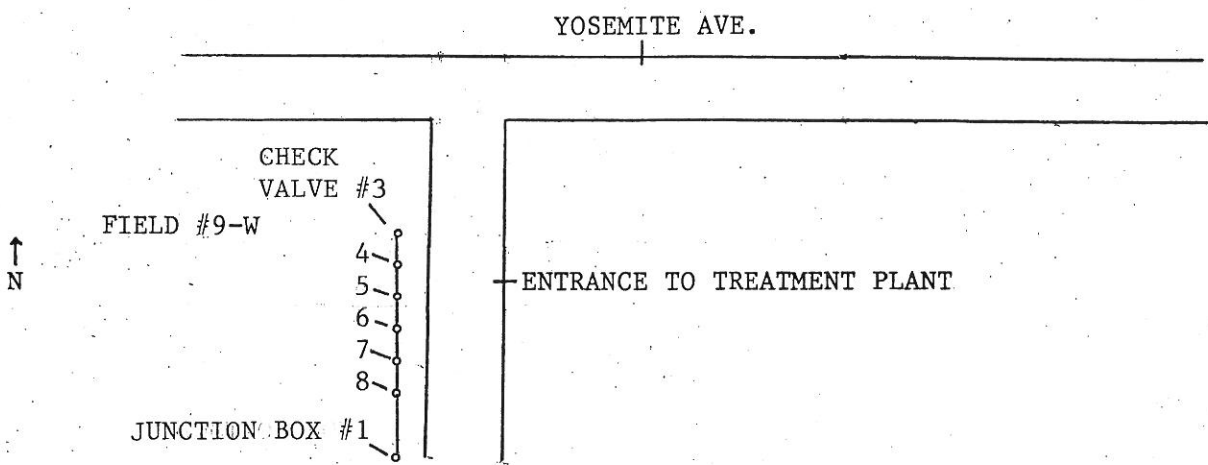
SHEET #: 8

LOCATION OF LINE: HEADING SOUTH ALONG THE WEST SIDE OF THE ENTRANCE ROAD TO TREATMENT PLANT

<u>FOOTAGE</u>	<u>FRAME</u>	<u>OBSERVATION</u>
4	00:00	START RUN AT CHECK VALVE #3
20	01:15	RADIAL CRACK IN THE PIPE
76	03:20	RADIAL CRACK IN THE PIPE
98	04:45	CHECK VALVE #4

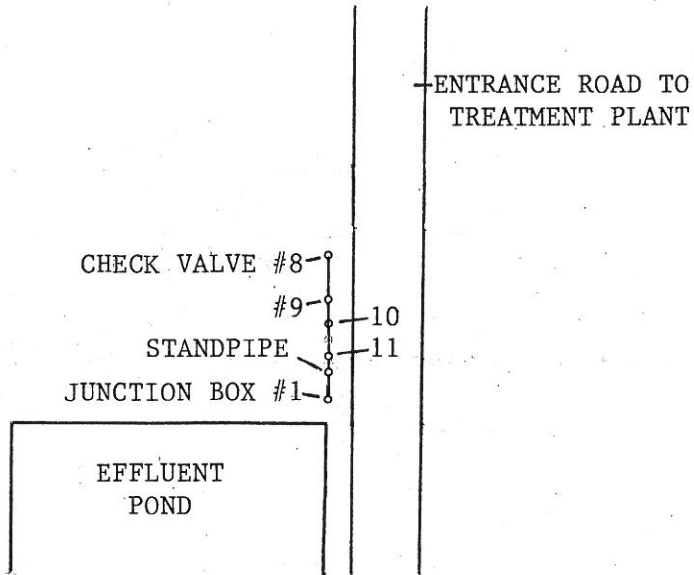
SHEET #: 10

LOCATION OF LINE: HEADING SOUTH ALONG THE WEST SIDE OF ENTRANCE ROAD TO THE TREATMENT PLANT

<u>FOOTAGE</u>	<u>FRAME</u>	<u>OBSERVATION</u>
4	00:00	START RUN AT CHECK VALVE #8
19	01:20	RADIAL CRACK IN THE PIPE - LIGHT ROOTS
100	04:30	CHECK VALVE #9
135	06:05	RADIAL CRACK IN THE PIPE

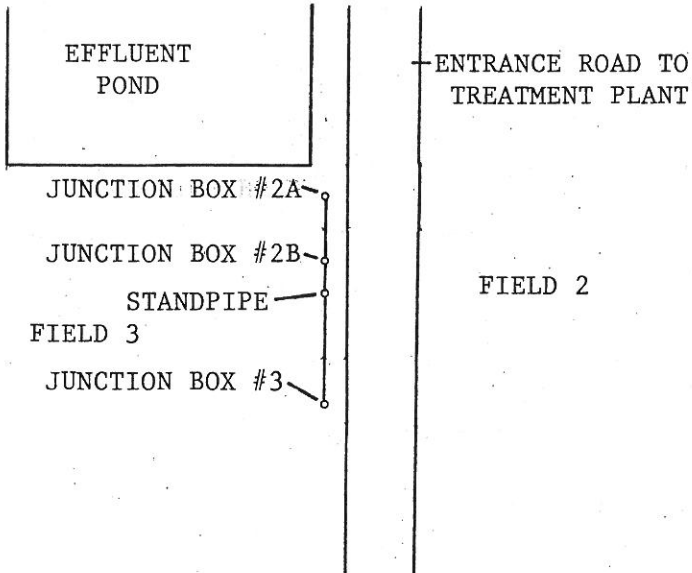
SHEET #: 12

LOCATION OF LINE: HEADING SOUTH BETWEEN FIELD #2 & FIELD #3

FOOTAGE	FRAME	OBSERVATION
4	00:00	START RUN AT JUNCTION BOX #2A
21	01:45	HAIRLINE RADIAL CRACK IN THE PIPE
158	06:45	RADIAL CRACK IN THE PIPE
328	10:58	JUNCTION BOX #2B

<u>FOOTAGE</u>	<u>FRAME</u>	<u>OBSERVATION</u>
459	13:40	STANDPIPE
548	15:55	RADIAL CRACK IN THE PIPE
753	20:45	PILE OF DEBRIS IN THE LINE
972	26:35	RADIAL CRACK IN THE PIPE
1066	30:30	END RUN A FEW FEET FROM JUNCTION BOX #3

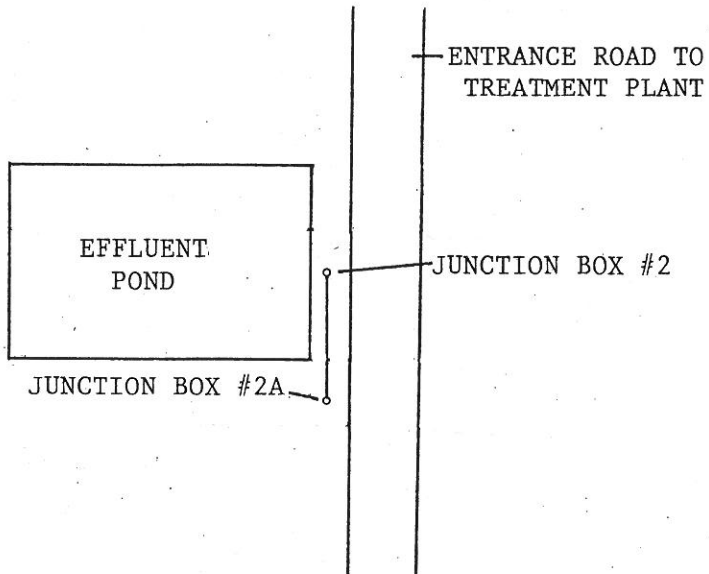
DATE: 2/25/13 **SHEET #:** 14

LOCATION OF LINE: HEADING NORTH FROM THE SOUTHEAST CORNER OF EFFLUENT POND

<u>FOOTAGE</u>	<u>FRAME</u>	<u>OBSERVATION</u>
4	00:00	START RUN AT JUNCTION BOX #2A
18	00:55	PIPE BENDS TO THE LEFT
49	03:00	END RUN AT JUNCTION BOX #2
