C.C.T.V. INSPECTION OF
IRRIGATION LINE IN MANTECA

DVD #2
2/25/13

CITY OF MANTECA
WASTEWATER QUALITY CONTROL FACILITY

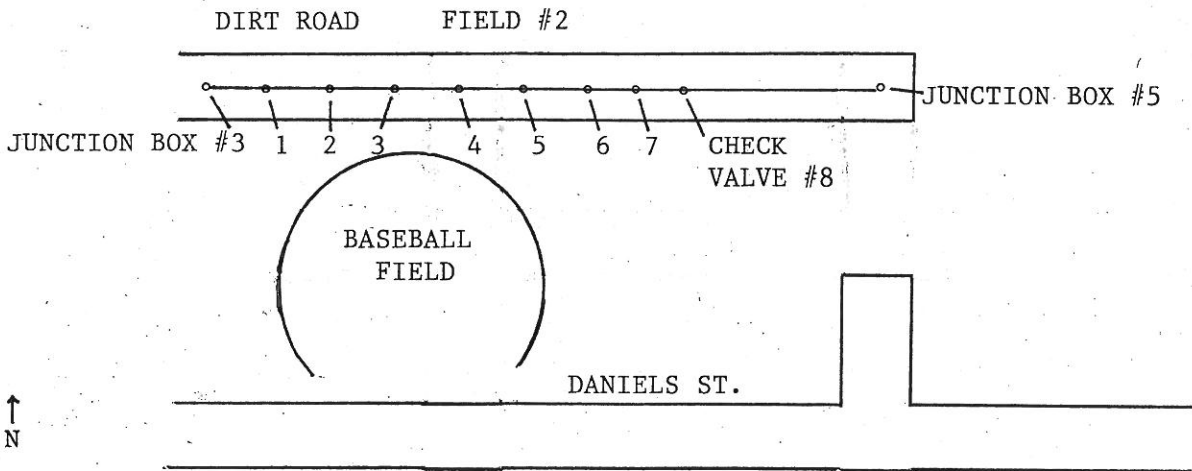
SHEET #: 15

LOCATION OF LINE: HEADING EAST ALONG THE NORTH SIDE OF BASEBALL FIELD

FOOTAGE	FRAME	OBSERVATION
5	00:00	START RUN AT JUNCTION BOX #3
31	02:15	PIPE BENDS TO THE LEFT
45	02:45	RADIAL CRACK IN THE PIPE
58 - 77	03:50	LONGITUDINAL CRACKS IN THE PIPE

<u>FOOTAGE</u>	<u>FRAME</u>	<u>OBSERVATION</u>
77	05:30	CHECK VALVE #1
78 - 187	05:50	LONGITUDINAL CRACK IN THE PIPE
188	09:30	CHECK VALVE #2
250	11:05	RADIAL CRACK IN THE PIPE
263 - 273	11:55	LONGITUDINAL CRACK IN THE PIPE
275	12:35	CHECK VALVE #3
282	13:05	DEBRIS IN THE LINE
291	14:00	STANDPIPE
291	14:00	RADIAL CRACK IN THE PIPE
362	16:05	RADIAL CRACK IN THE PIPE
377	17:05	CHECK VALVE #4
472	19:10	CHECK VALVE #5
493	19:55	RADIAL CRACK IN THE PIPE
560	22:05	CHECK VALVE #6
635 - 648	24:20	LONGITUDINAL CRACK IN THE PIPE
661	25:15	CHECK VALVE #7
661	25:20	START SAG
764	29:05	STANDPIPE
771	30:08	CHECK VALVE #8

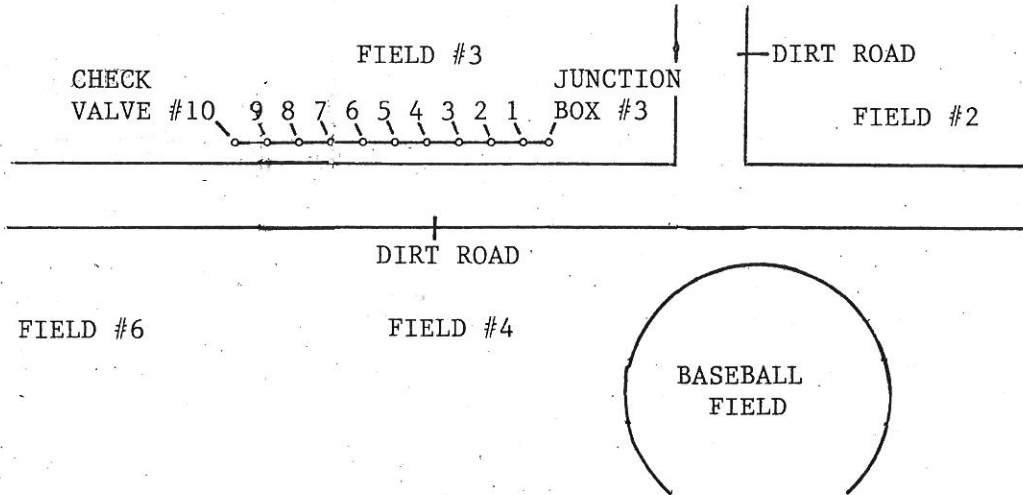
SHEET #: 17

LOCATION OF LINE: HEADING EAST BETWEEN FIELD #3 & FIELD #4

<u>FOOTAGE</u>	<u>FRAME</u>	<u>OBSERVATION</u>
4	00:00	START RUN AT CHECK VALVE #10
26	01:20	RADIAL CRACK IN THE PIPE
47	02:35	CHECK VALVE #9
93	04:10	CHECK VALVE #8

<u>FOOTAGE</u>	<u>FRAME</u>	<u>OBSERVATION</u>
95 - 132	04:30	HAIRLINE LONGITUDINAL CRACK IN THE PIPE
138	06:35	CHECK VALVE #7
183	06:40	CHECK VALVE #6
206	08:40	RADIAL CRACK IN THE PIPE - LIGHT ROOTS
226	10:00	CHECK VALVE #5
274	11:05	CHECK VALVE #4
315	12:05	CHECK VALVE #3
320	12:45	ROOTS IN PIPE - LIGHT
340	13:40	RADIAL CRACK IN THE PIPE
361	14:40	PATCH
406	15:50	CHECK VALVE #2
448	17:00	DEBRIS IN THE LINE
455	17:25	CHECK VALVE #1
458	17:40	DEBRIS IN THE LINE
475 - 486	18:00	DEBRIS IN THE LINE
486	21:52	END RUN - TRACTOR CANNOT GET PAST THE DEBRIS IN THE LINE

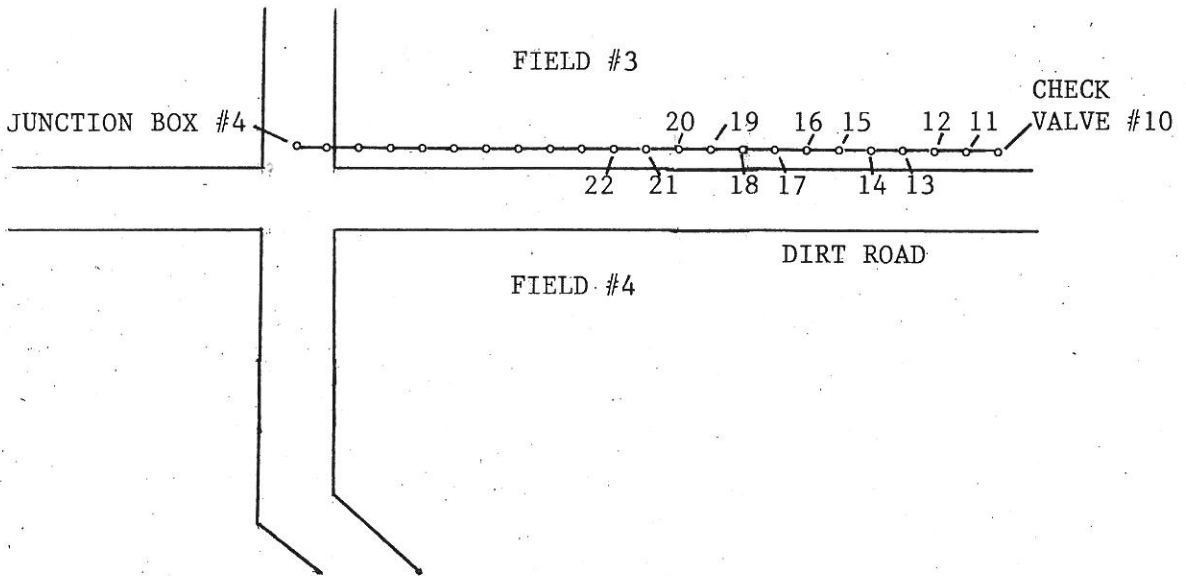
SHEET #: 19

LOCATION OF LINE: HEADING WEST BETWEEN FIELD #3 & FIELD #4

FOOTAGE	FRAME	OBSERVATION
4	00:00	START RUN AT CATCH VALVE #10
26	01:05	RADIAL CRACK IN THE PIPE
40	01:55	STANDPIPE
43	02:20	CATCH VALVE #11

<u>FOOTAGE</u>	<u>FRAME</u>	<u>OBSERVATION</u>
82	03:20	CHECK VALVE #12
99	04:05	RADIAL CRACK IN THE PIPE
134	05:00	CHECK VALVE #13
169	06:00	RADIAL CRACK IN THE PIPE
169	06:05	HAIRLINE LONGITUDINAL CRACK IN THE PIPE
173	06:50	CHECK VALVE #14
177 - 202	07:15	HAIRLINE LONGITUDINAL CRACK IN THE PIPE
199	07:55	RADIAL CRACK IN THE PIPE
223	08:55	CHECK VALVE #15
242	09:50	RADIAL CRACK IN THE PIPE
242	09:50	HAIRLINE LONGITUDINAL CRACK IN THE PIPE
262	10:35	CHECK VALVE #16
284 - 309	11:05	DEBRIS IN THE LINE
312	11:50	CHECK VALVE #17
350	12:55	STANDPIPE
354	13:25	CHECK VALVE #18
402	14:35	CHECK VALVE #19
488	16:45	CHECK VALVE #20
491	17:15	RADIAL CRACK IN THE PIPE
507	17:50	CHECK VALVE #21
507 - 536	18:10	LONGITUDINAL CRACK IN THE PIPE
529	18:55	RADIAL CRACK IN THE PIPE
560	19:50	RADIAL CRACK IN THE PIPE
578	20:25	STANDPIPE
581	21:10	CHECK VALVE #22

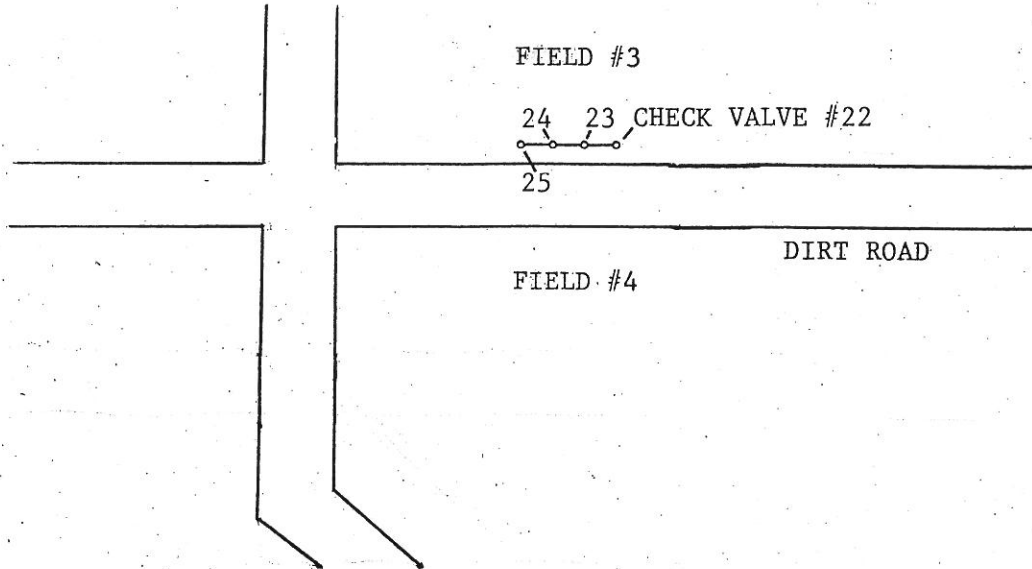
SHEET #: 22

LOCATION OF LINE: HEADING EAST BETWEEN FIELD #3 & FIELD #4

<u>FOOTAGE</u>	<u>FRAME</u>	<u>OBSERVATION</u>
4	00:00	START RUN AT CHECK VALVE #25
42	01:20	RADIAL CRACK IN THE PIPE
78	02:10	DEBRIS IN THE LINE
90 - 100	02:35	CHECK VALVE #24

<u>FOOTAGE</u>	<u>FRAME</u>	<u>OBSERVATION</u>
105 - 117	03:20	HAIRLINE LONGITUDINAL CRACK IN THE PIPE
110	03:50	HAIRLINE RADIAL CRACK IN THE PIPE
138	05:15	CHECK VALVE #23
140	05:40	HAIRLINE LONGITUDINAL CRACK IN THE PIPE
180	06:40	HAIRLINE LONGITUDINAL CRACK IN THE PIPE WITH ROOTS
181	07:15	END RUN AT CHECK VALVE #22

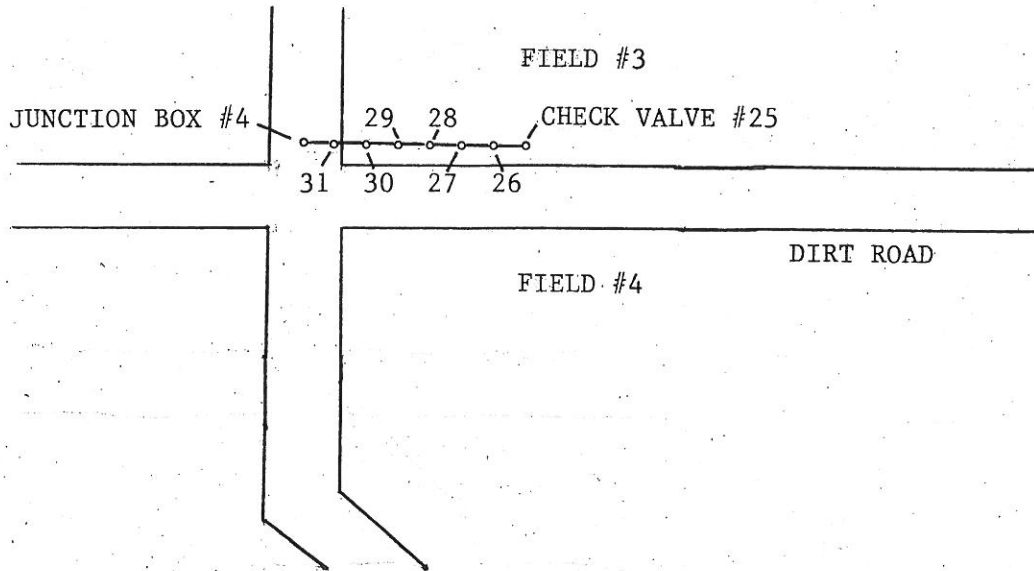
SHEET #: 24

LOCATION OF LINE: HEADING WEST FROM FIELD #3 & FIELD #4

<u>FOOTAGE</u>	<u>FRAME</u>	<u>OBSERVATION</u>
4	00:00	START RUN AT CHECK VALVE #25
17	01:20	RADIAL CRACK IN THE PIPE
21 - 43	02:10	HAIRLINE LONGITUDINAL CRACK IN THE PIPE
32	02:50	RADIAL CRACK IN THE PIPE

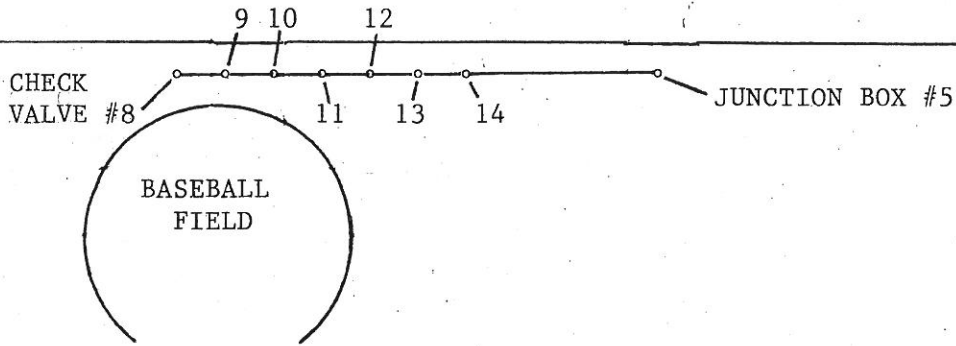
SHEET #: 26

LOCATION OF LINE: HEADING EAST ALONG THE NORTH SIDE OF BASEBALL FIELD

<u>FOOTAGE</u>	<u>FRAME</u>	<u>OBSERVATION</u>
4	00:00	START RUN AT CHECK VALVE #8
72	02:00	CHECK VALVE #9
135	03:15	CHECK VALVE #10
180	04:05	DEBRIS IN THE LINE

<u>FOOTAGE</u>	<u>FRAME</u>	<u>OBSERVATION</u>
187	04:30	CHECK VALVE #11
242	05:40	CHECK VALVE #12
288	06:40	HEAVY SAND IN THE LINE
290	07:05	CHECK VALVE #13
301	07:20	HEAVY DEBRIS IN THE LINE
339	11:25	CHECK VALVE #14
368	13:56	END RUN - AS FAR AS TRACTOR CAN GO - TOO MUCH MUD IN THE LINE
