# **Video → Inspection Specialists**

C.C.T.V. INSPECTION OF  
IRRIGATION LINE IN MANTECA

DVD #3  
2/26/13

CITY OF MANTECA  
WASTEWATER QUALITY CONTROL FACILITY

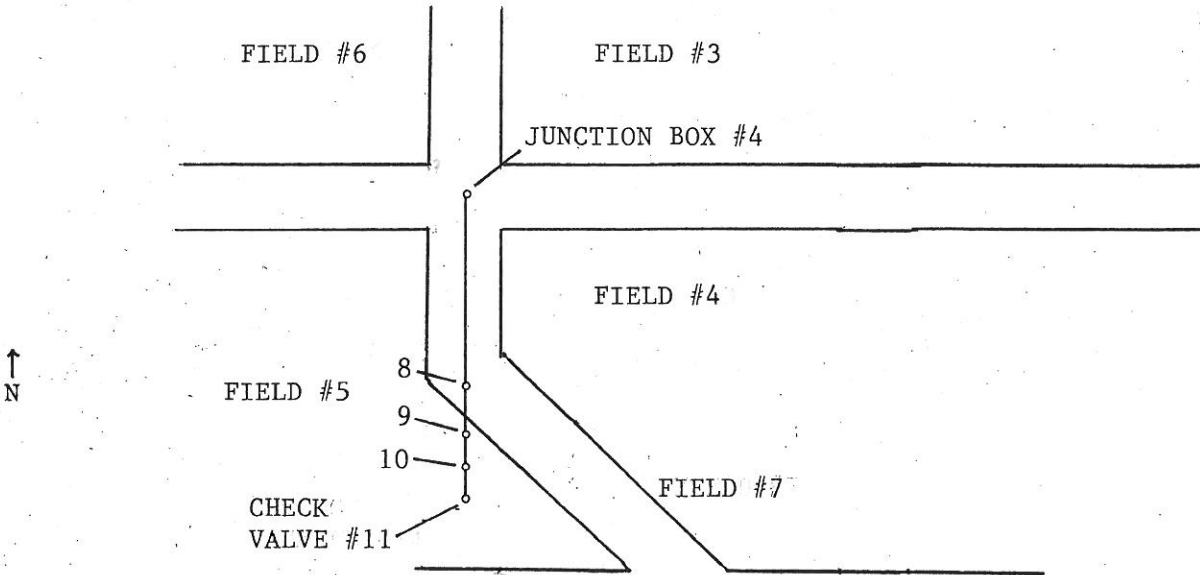
SHEET #: 28

LOCATION OF LINE: HEADING NORTH BETWEEN FIELD #4 & FIELD #5

<u>FOOTAGE</u>	<u>FRAME</u>	<u>OBSERVATION</u>
4	00:00	START RUN AT CHECK VALVE #11
4	00:35	STANDING WATER IN THE LINE
39	01:50	CHECK VALVE #10
113	03:20	CHECK VALVE #9

<u>FOOTAGE</u>	<u>FRAME</u>	<u>OBSERVATION</u>
188	04:55	CHECK VALVE #8
216 - 220	05:45	DEBRIS IN THE LINE
217	06:00	CHECK VALVE #7
220	07:25	END RUN - TRACTOR CANNOT GET PAST HEAVY DEBRIS IN THE LINE

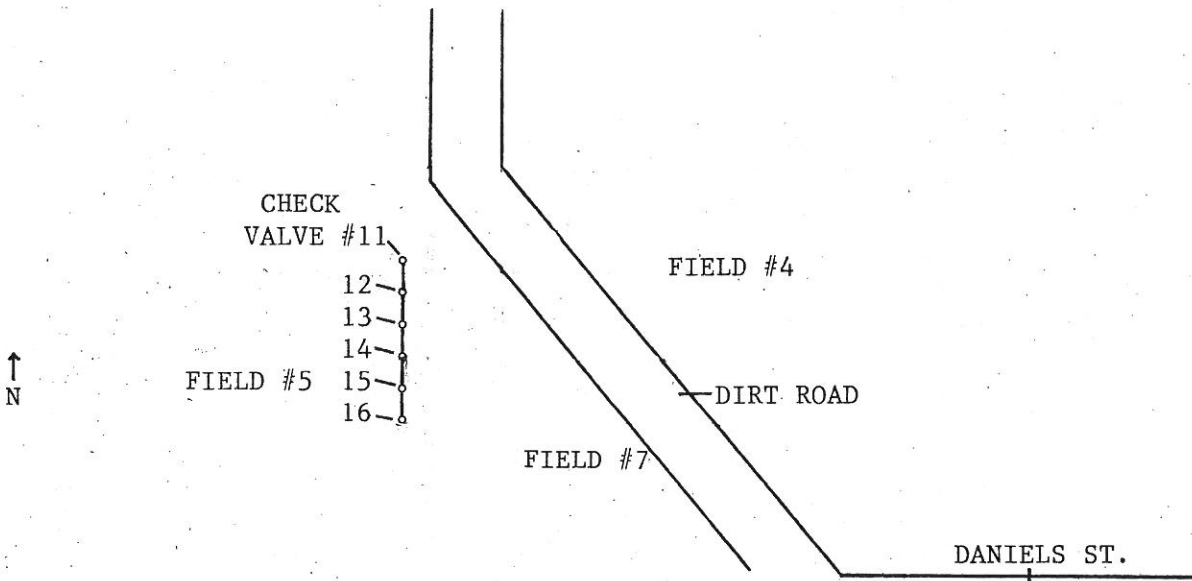
SHEET #: 30

LOCATION OF LINE: HEADING SOUTH BETWEEN FIELD #5 & FIELD #10

<u>FOOTAGE</u>	<u>FRAME</u>	<u>OBSERVATION</u>
4	00:00	START RUN AT CHECK VALVE #11 - HEAVY DEBRIS IN LINE AT CV #11
35	01:50	STANDPIPE
40	02:20	CHECK VALVE #12
118	04:15	CHECK VALVE #13

<u>FOOTAGE</u>	<u>FRAME</u>	<u>OBSERVATION</u>
165	05:25	RADIAL CRACK IN THE PIPE
198	07:15	CHECK VALVE #14
212	07:45	RADIAL CRACK IN THE PIPE
274	09:25	CHECK VALVE #15
278	10:05	CHECK VALVE #16
278 - 280	10:25	DEBRIS IN THE LINE
280	11:56	END RUN - TRACTOR CANNOT GET PAST DEBRIS IN THE LINE

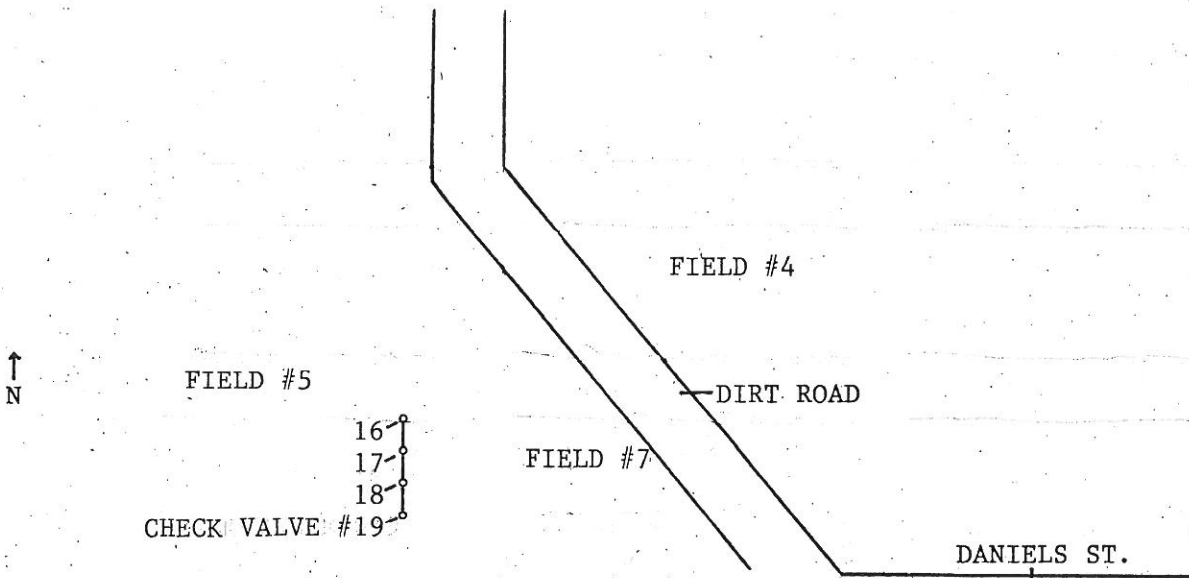
SHEET #: 32

LOCATION OF LINE: HEADING NORTH BETWEEN FIELD #5 & FIELD #7

FOOTAGE	FRAME	OBSERVATION
4	00:00	START RUN AT CHECK VALVE #19
4	00:35	DEBRIS IN THE LINE
4	00:35	DEBRIS IN THE LINE
66 - 72	02:05	HEAVY DEBRIS IN THE LINE

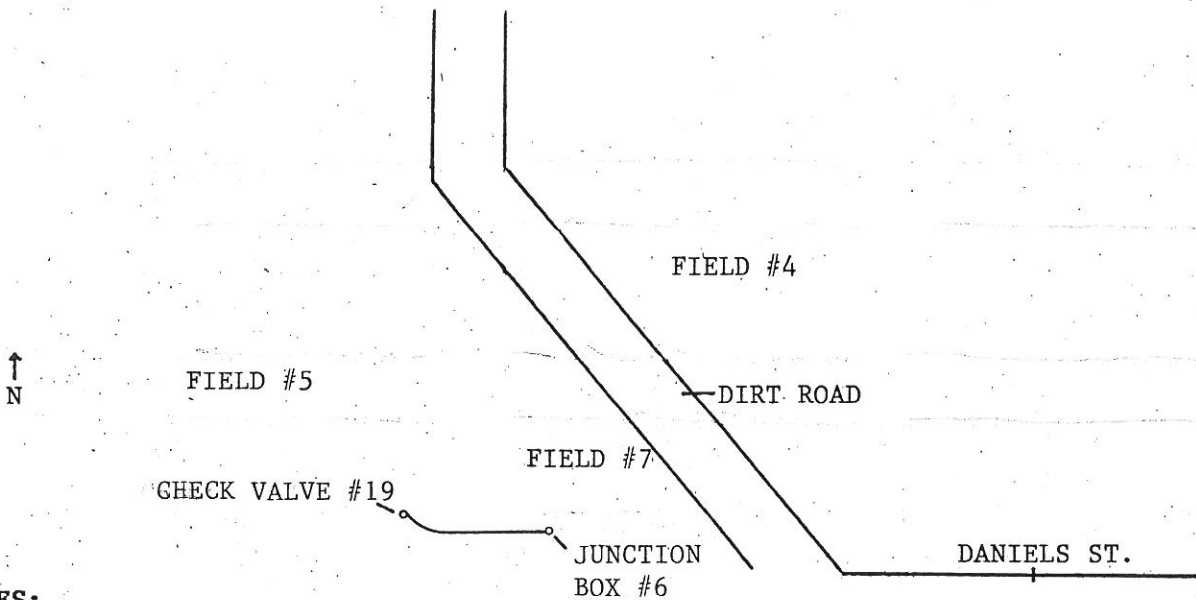
SHEET #: 34

LOCATION OF LINE: HEADING EAST ALONG THE SOUTH SIDE OF FIELD #7

<u>FOOTAGE</u>	<u>FRAME</u>	<u>OBSERVATION</u>
4	00:00	START RUN AT CHECK VALVE #19
14	00:50	PIPE TURNS TO THE LEFT
100	03:25	RADIAL CRACK IN THE PIPE
154	05:15	RADIAL CRACK IN THE PIPE

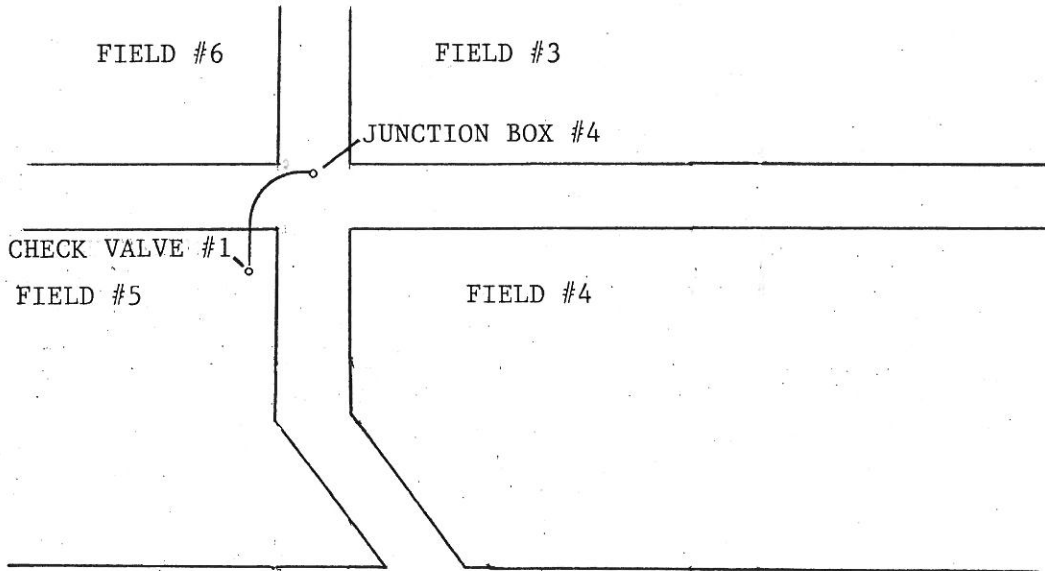
SHEET #: 36

LOCATION OF LINE: HEADING NROTH BETWEEN FIELD #4 & FIELD #5

<u>FOOTAGE</u>	<u>FRAME</u>	<u>OBSERVATION</u>
4	00:00	START RUN AT CHECK VALVE #1
4	00:30	START SAG
64	01:35	PIPE TURNS TO THE RIGHT
83	02:15	PATCH ON TOP

<u>FOOTAGE</u>	<u>FRAME</u>	<u>OBSERVATION</u>
83	02:35	PIPE CROSSING THROUGH TOP PORTION OF IRRIGATION LINE
88	03:25	END SAG
89	03:30	PIPE TURNS SHARP TO THE RIGHT
116	04:30	PIPE TURNS UPWARD & TO THE RIGHT & REDUCES IN SIZE
118	05:12	END RUN - PIPE REDUCES IN SIZE - TRACTOR CANNOT GET PAST

THE TURN UPWARD

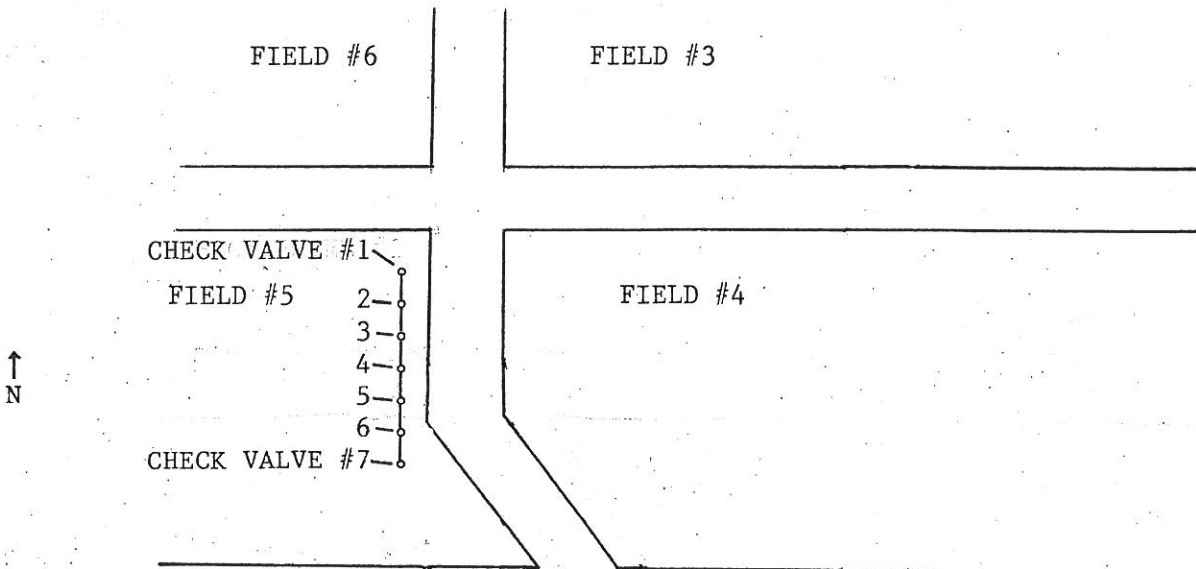
SHEET #: 38

LOCATION OF LINE: HEADING SOUTH BETWEEN FIELD #4 & FIELD #5

<u>FOOTAGE</u>	<u>FRAME</u>	<u>OBSERVATION</u>
4	00:00	START RUN AT CHECK VALVE #1
4	00:35	STRAT SAG
75	01:55	CATCH VALVE #2
148	03:25	LONGITUDINAL CRACK IN THE PIPE

<u>FOOTAGE</u>	<u>FRAME</u>	<u>OBSERVATION</u>
149	03:45	CHECK VALVE #3
184	04:30	PIPE TURNS TO THE LEFT
219	05:25	RADIAL CRACK IN THE PIPE
225	06:00	CHECK VALVE #4
294	07:20	STANDPIPE
299	07:40	CHECK VALVE #5
376	09:20	CHECK VALVE #6
419	10:50	CHECK VALVE #7 - HEAVY DEBRIS IN THE LINE

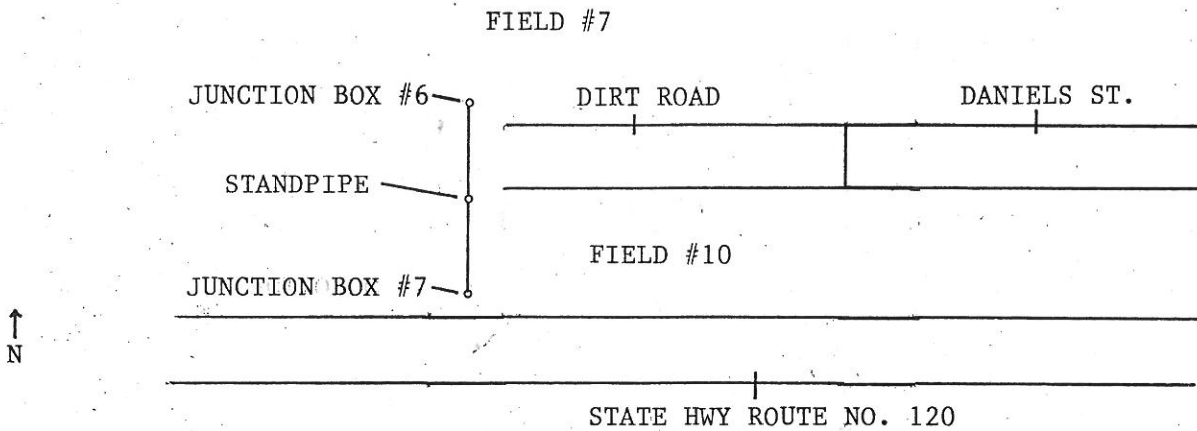
SHEET #: 40

LOCATION OF LINE: HEADING SOUTH ALONG THE WEST SIDE OF FIELD #10

FOOTAGE	FRAME	OBSERVATION
4	00:00	START RUN AT JUNCTION BOX #6
92	02:15	RADIAL CRACK IN THE PIPE
203	04:55	RADIAL CRACK IN THE PIPE
435	09:25	LONGITUDINAL CRACK IN THE PIPE
