# Video → Inspection Specialists

C.C.T.V. INSPECTION OF  
IRRIGATION LINE IN MANTECA

3/4/13

CITY OF MANTECA  
WASTEWATER QUALITY CONTROL FACILITY

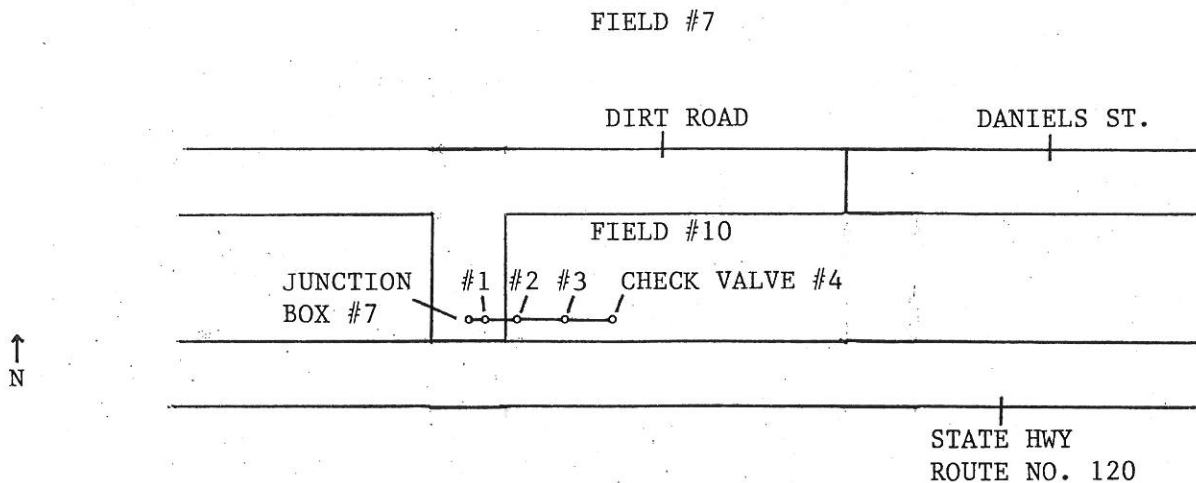
DATE: 3/4/13 SHEET #: 42

LOCATION OF LINE: HEADING WEST ALONG THE SOUTH SIDE OF FIELD #10

FOOTAGE	FRAME	OBSERVATION
4	00:00	START RUN AT CHECK VALVE #4
4	00:30	HEAVY DEBRIS IN THE CHECK VALVE #4
96	03:00	HEAVY DEBRIS IN THE LINE
100	03:15	CHECK VALVE #3

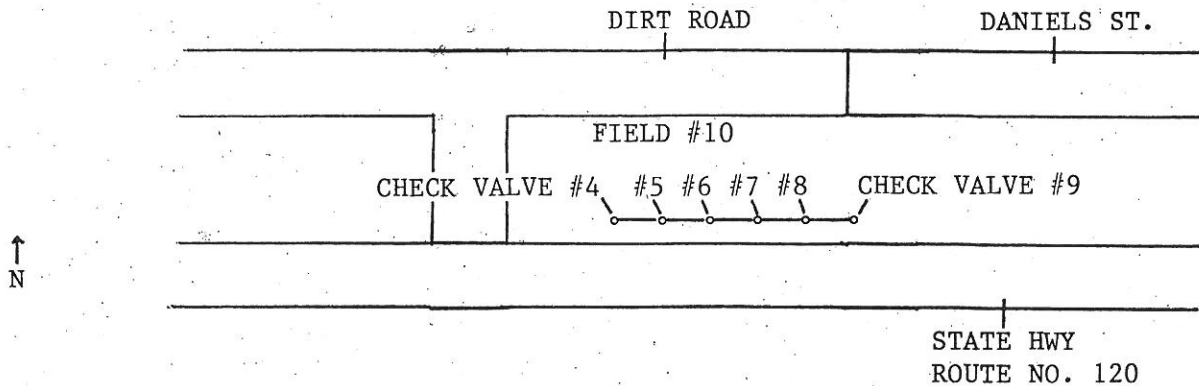
FOOTAGE	FRAME	OBSERVATION
4	00:00	START RUN AT CHECK VALVE #4
30	01:15	PATCH
31	01:30	RADIAL CRACK IN THE PIPE
96	02:55	DEBRIS IN THE LINE

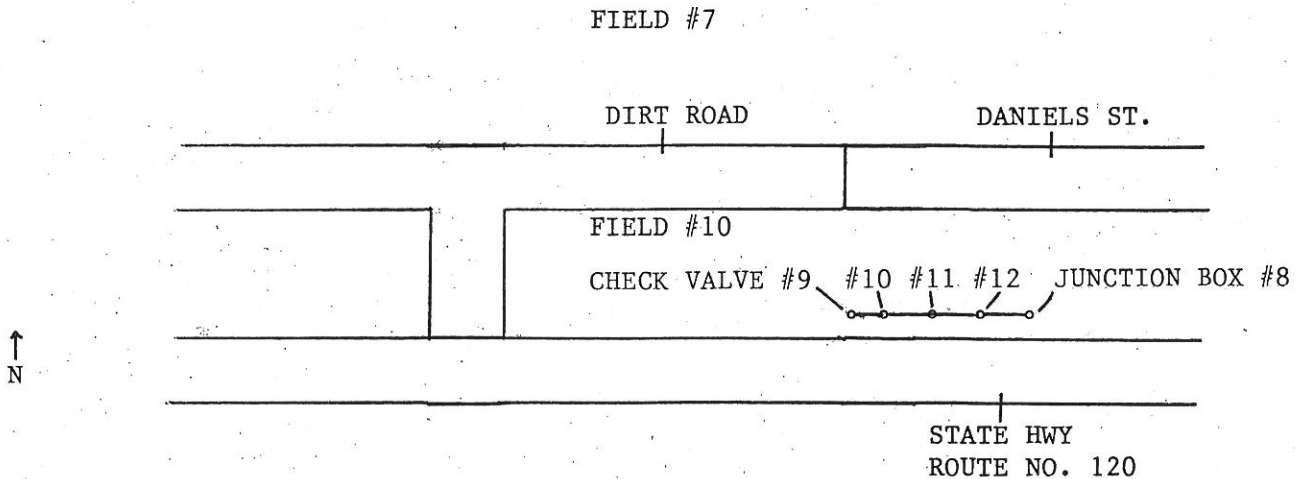
DATE: 3/4/13 SHEET #: 46

HEAVY MUD IN THE LINE

<u>FOOTAGE</u>	<u>FRAME</u>	<u>OBSERVATION</u>
4	00:00	START RUN AT CHECK VALVE #9
4	00:30	MUD IN THE LINE
39	01:40	RADIAL CRACK IN THE PIPE
97	02:50	DEBRIS IN THE LINE

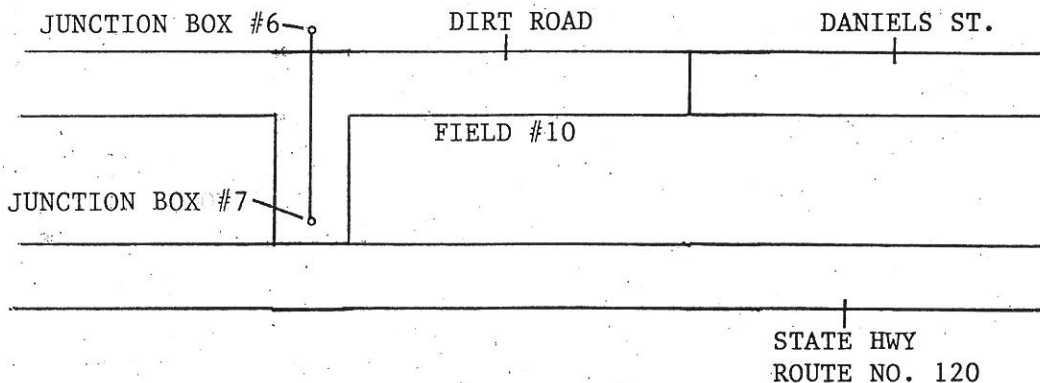
SHEET #: 48

<u>FOOTAGE</u>	<u>FRAME</u>	<u>OBSERVATION</u>
4	00:00	START RUN AT JUNCTION BOX #7
10	00:50	PIPE TURNS TO THE LEFT
17	01:10	STANDPIPE
32	01:50	RADIAL CRACK IN THE PIPE

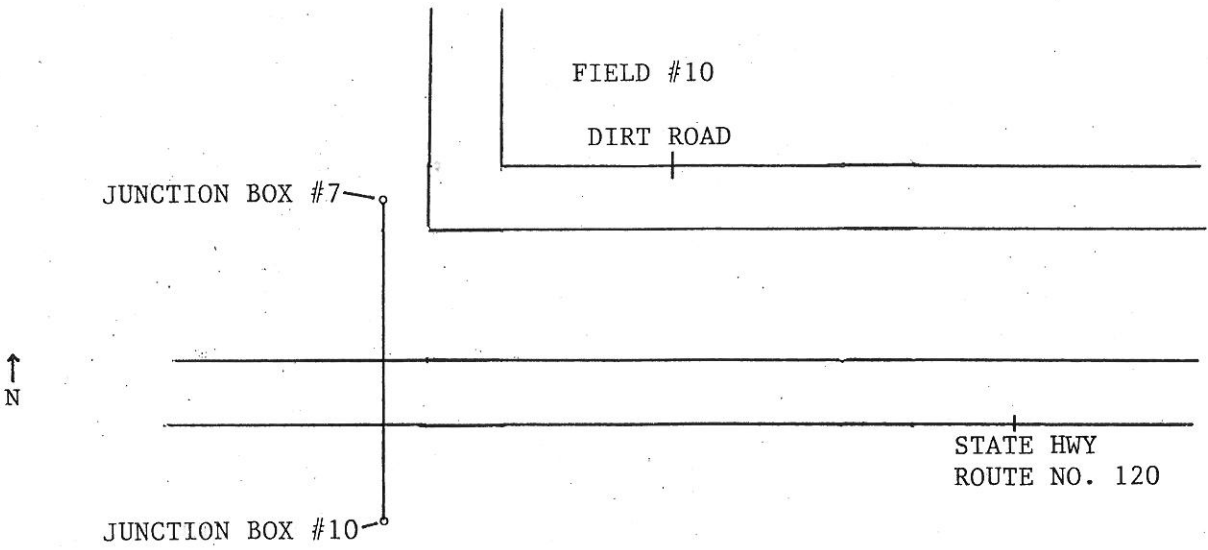
DATE: 3/4/13 SHEET #: 50

FOOTAGE	FRAME	OBSERVATION
4	00:00	START RUN AT JUNCTION BOX #7
4	00:30	STANDPIPE
285	05:00	PIPE TURNS TO THE LEFT
307	05:46	END RUN AT JUNCTION BOX #10

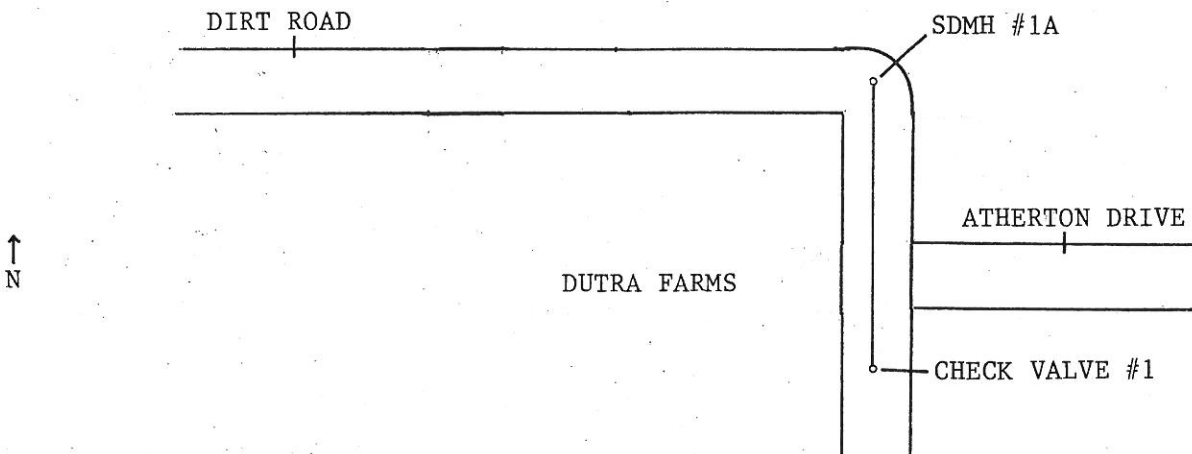
**DATE:** 3/4/13 **SHEET #:** 51

<u>FOOTAGE</u>	<u>FRAME</u>	<u>OBSERVATION</u>
4	00:00	START RUN AT CHECK VALVE #1
109	02:41	END RUN AT STORM DRAIN MANHOLE #1A

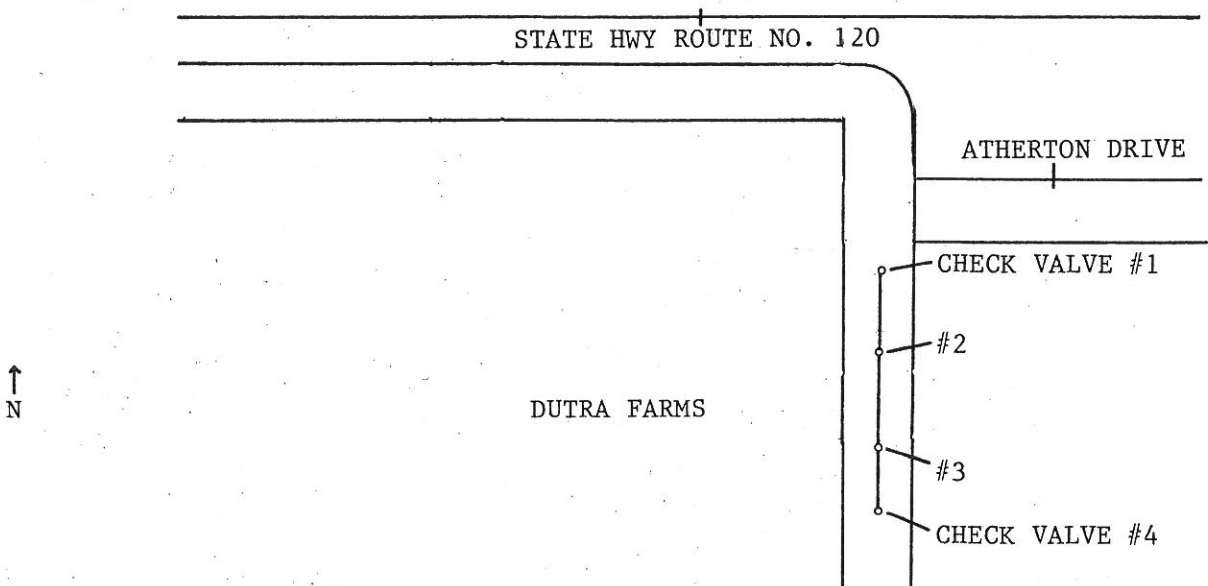
SHEET #: 52

FOOTAGE	FRAME	OBSERVATION
4	00:00	START RUN AT CHECK VALVE #1
7	00:35	STANDPIPE
78	02:00	START SAG
122	02:40	CAMERA IS UNDER THE FLOW

<u>FOOTAGE</u>	<u>FRAME</u>	<u>OBSERVATION</u>
142	03:00	THE CAMERA IS ABOVE THE FLOW
200	03:55	CHECK VALVE #2
232	04:35	END SAG
265	05:10	START SAG - CONTINUED TO CHECK VALVE #4
401	07:15	CHECK VALVE #3
600	11:02	END RUN AT CHECK VALVE #4

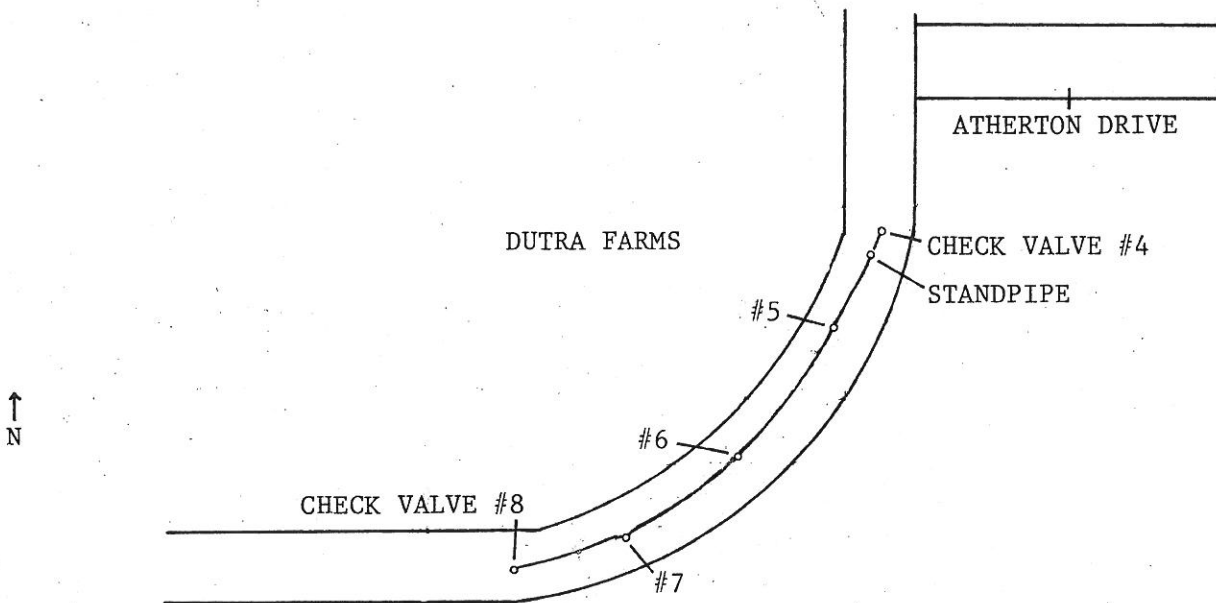
SHEET #: 54

FOOTAGE	FRAME	OBSERVATION
4	00:00	START RUN AT CHECK VALVE #4 - START SAG - WATER CONTINUED TO CHECK VALVE #8
9	00:45	STANDPIPE
187	03:50	CHECK VALVE #5
397	07:10	CHECK VALVE #6

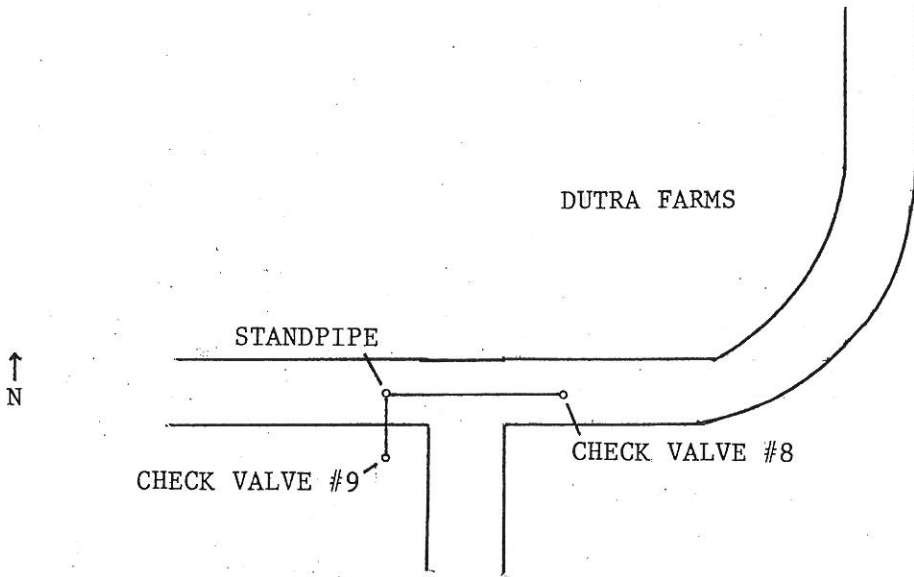
FOOTAGE	FRAME	OBSERVATION
4	00:00	START RUN AT CHECK VALVE #8
4	00:30	SOME STANDING WATER IN THE LINE
80	01:55	STANDPIPE
80	02:06	LINE TAKES A 90° TURN TO THE LEFT

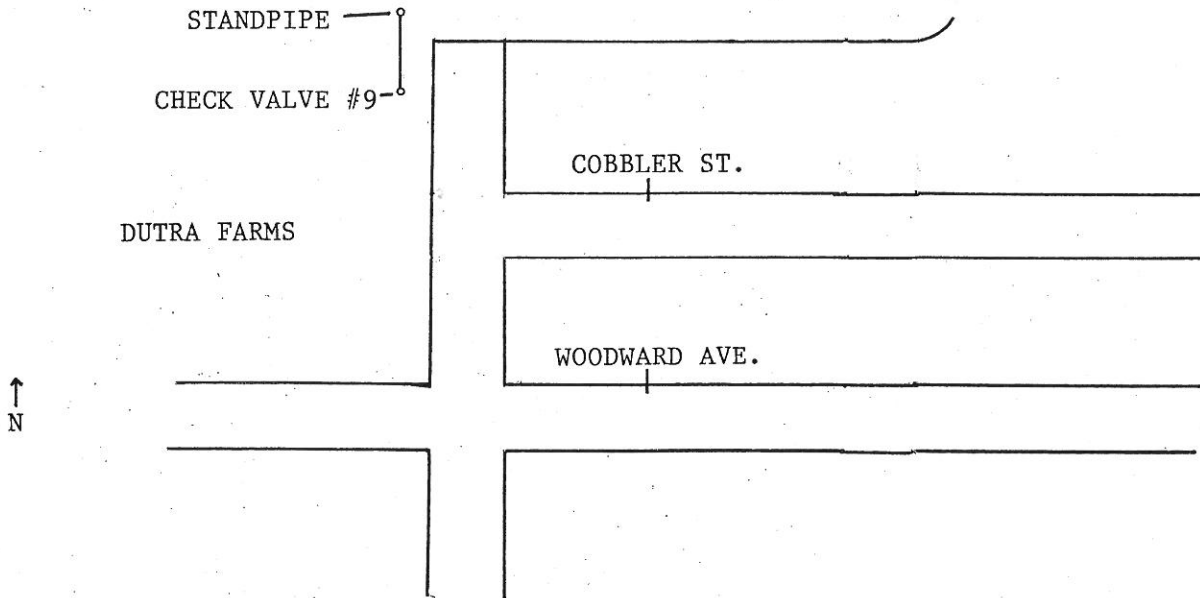
SHEET #: 57

<u>FOOTAGE</u>	<u>FRAME</u>	<u>OBSERVATION</u>
4	00:00	START RUN AT CHECK VALVE #9
85	02:00	END RUN AT STANDPIPE

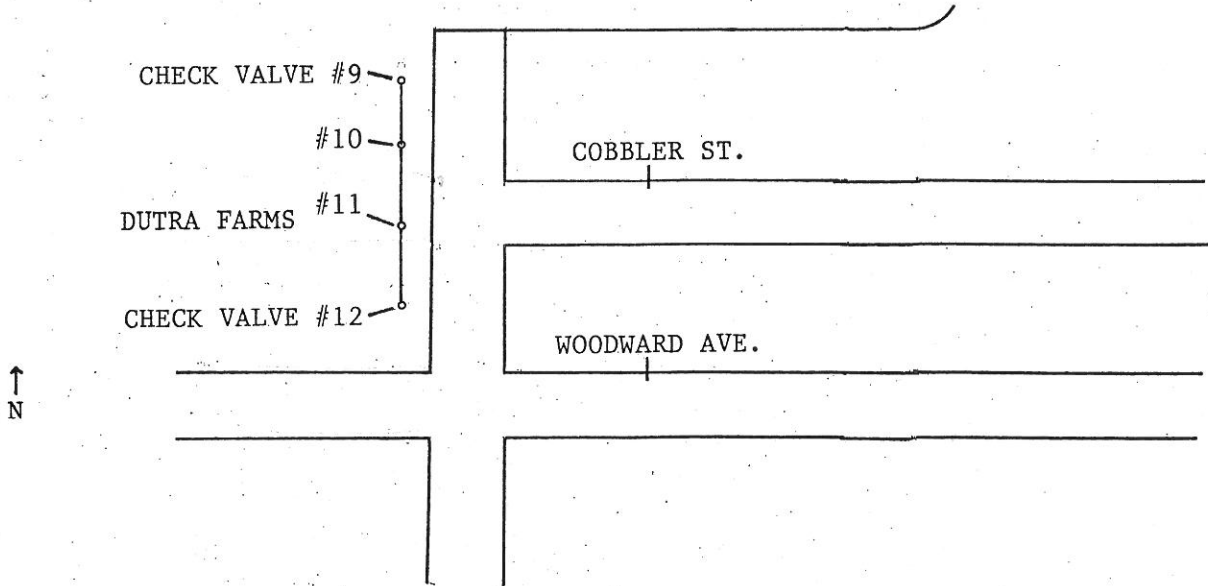
**DATE:** 3/4/13 **SHEET #:** 58

<u>FOOTAGE</u>	<u>FRAME</u>	<u>OBSERVATION</u>
4	00:00	START RUN AT CHECK VALVE #9 - SOME STANDING WATER
8	00:35	STANDPIPE
201	03:40	CHECK VALVE #10
434	07:40	CHECK VALVE #11

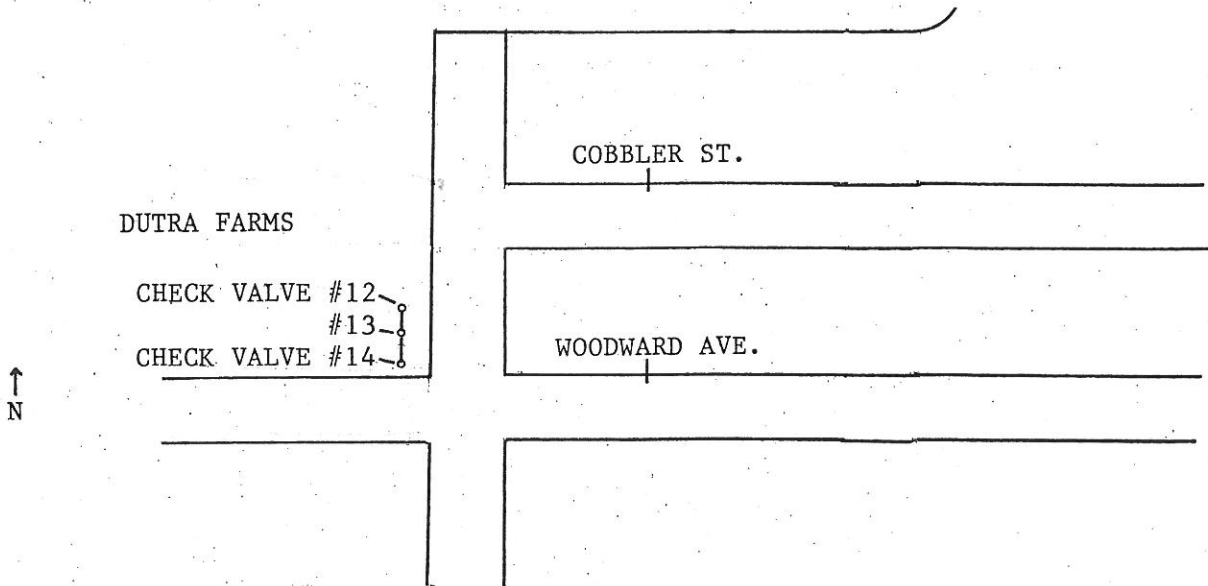
**SHEET #:** 60

<u>FOOTAGE</u>	<u>FRAME</u>	<u>OBSERVATION</u>
0	00:00	START RUN AT CHECK VALVE #2
154	03:05	STANDPIPE
210	04:15	CHECK VALVE #13

END RUN AT CHECK VALVE #14 - LINE ENDS - CAP

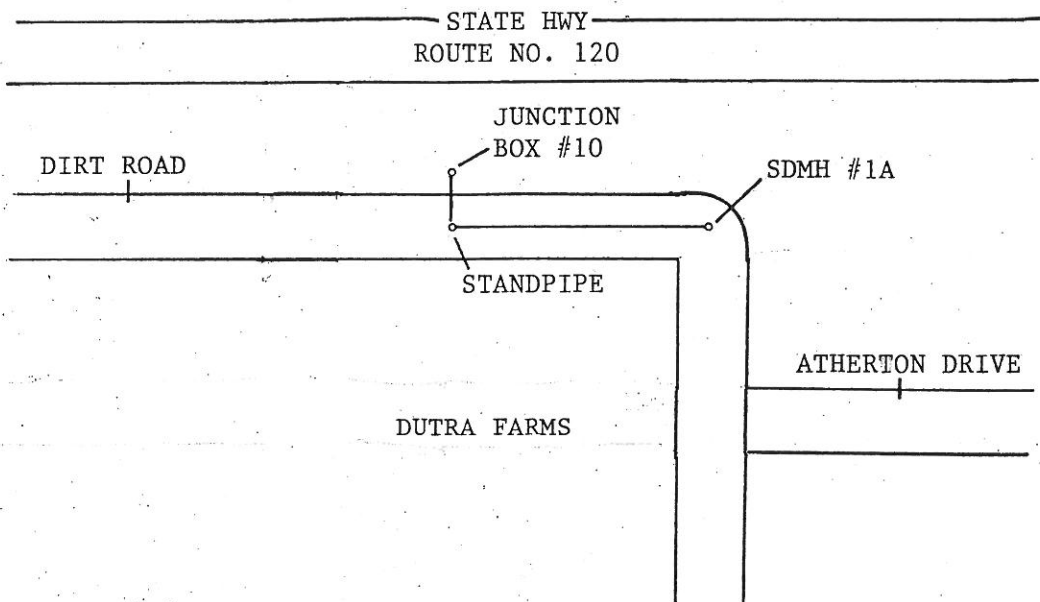
**DATE:** 3/4/13 **SHEET #:** 62

<u>FOOTAGE</u>	<u>FRAME</u>	<u>OBSERVATION</u>
6	00:00	START RUN AT STORM DRAIN MANHOLE #1A
15	01:00	RADIAL CRACK IN THE PIPE
175	03:40	PIPE TURNS RIGHT
196	04:20	HEAVY DEBRIS IN THE LINE - CONCRETE

<u>FOOTAGE</u>	<u>FRAME</u>	<u>OBSERVATION</u>
202	04:45	STANDPIPE
306	06:40	RADIAL CRACK IN THE PIPE
347	07:45	STANDPIPE
353	08:30	END RUN AT JUNCTION BOX #10
