City of Manteca Wastewater Quality Control Facility Influent Pump Station Condition Assessment

Prepared for: Phil Govea, P.E., City of Manteca

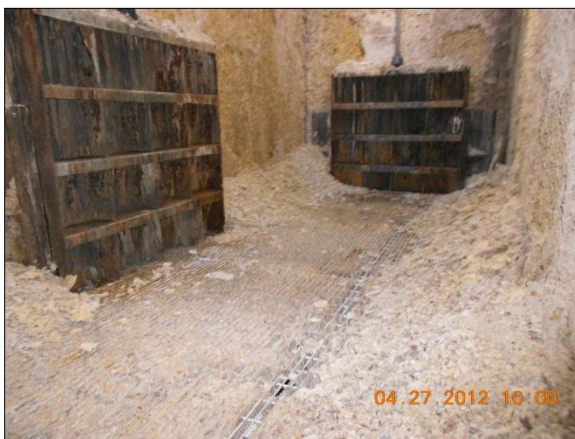
Photo 1. View of Influent Room looking at west wall showing pile of deteriorated concrete around perimeter of grating.

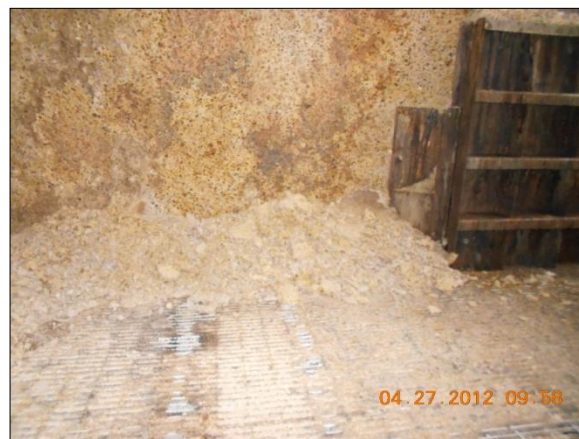
Photo 2. View of Influent Room looking at south wall showing pile of deteriorated concrete around perimeter of grating.

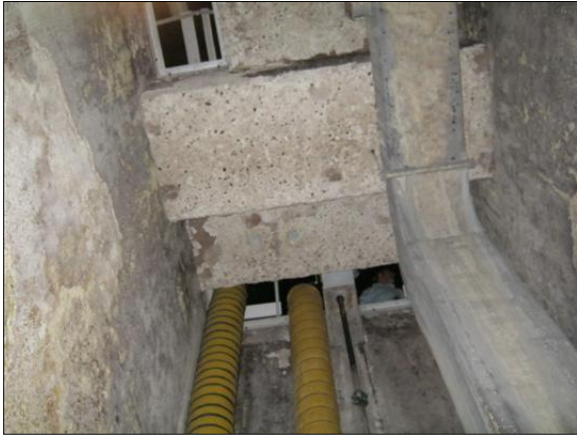
Photo 3. View of Influent Room looking at roof showing deteriorated concrete on walls and roof.

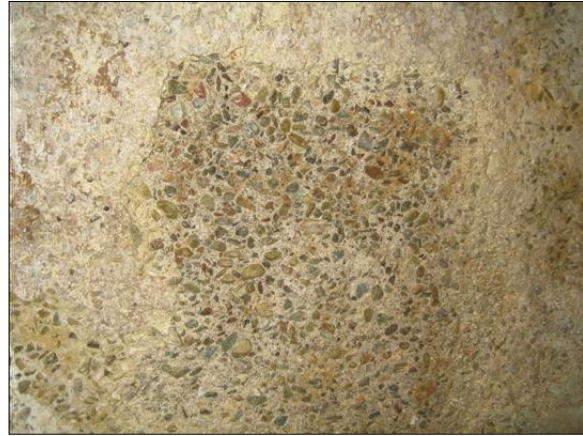
Photo 4. Pressure-washed area showing medium and large diameter aggregate, but no reinforcing steel.

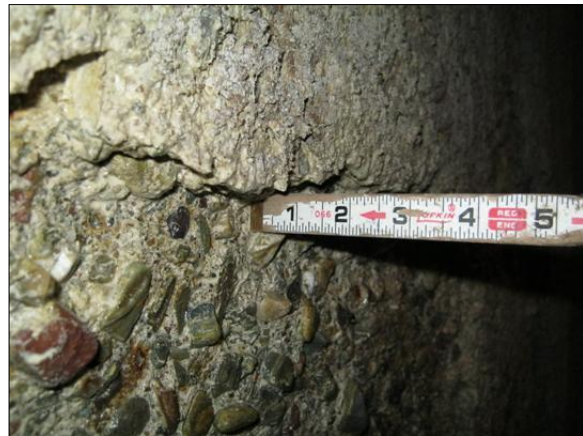
Photo 6. Side profile of concrete wall deterioration showing approximately 1.75 inches of concrete lost.

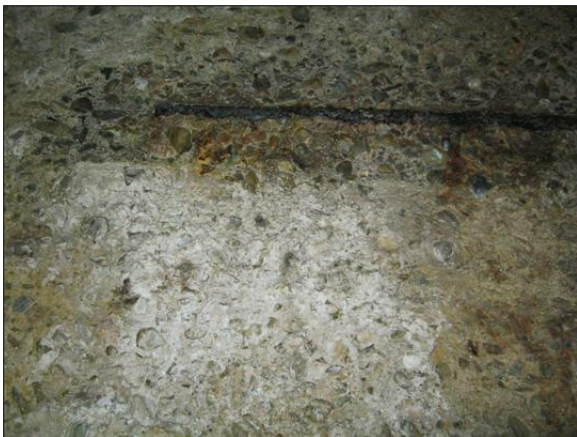
Photo 7. Exposed stray reinforcing steel on south wall.

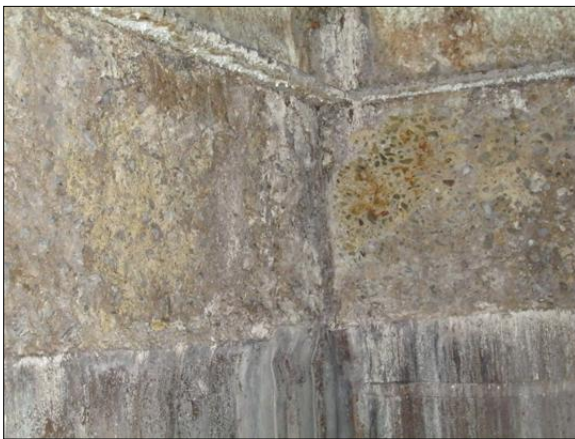
Photo 9. PVC T-lock liner termination below grating.

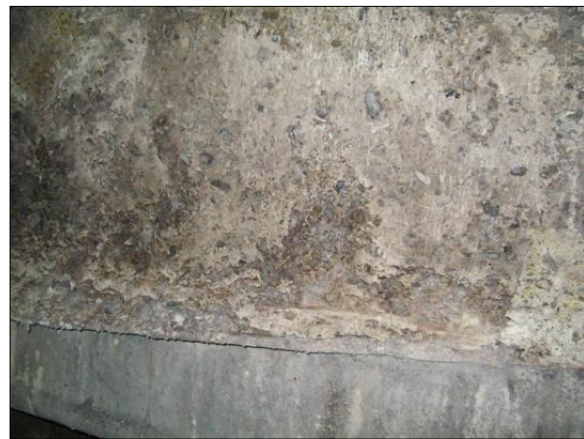
Photo 10. PVC T-Lock liner delaminating away from deteriorated concrete.

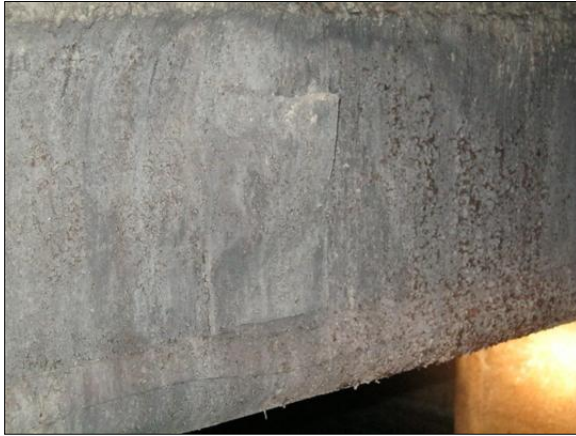
Photo 11. T-lock liner away from termination edge in good condition.

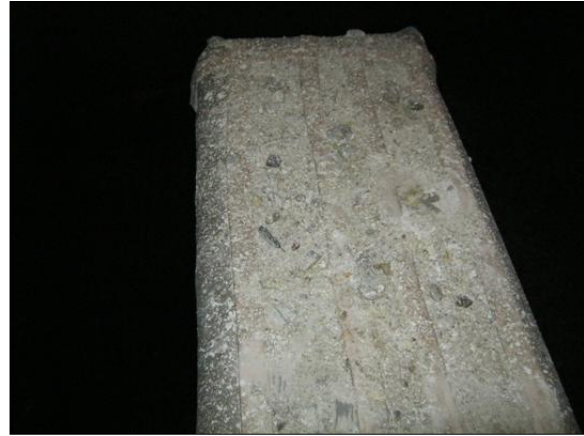
Photo 12. T-Lock liner on baffle wall in good condition.

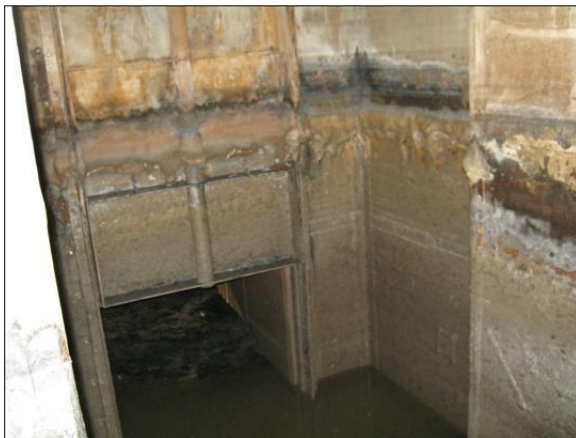
Photo 13. PVC T-Lock on walls of flow channel in good condition.

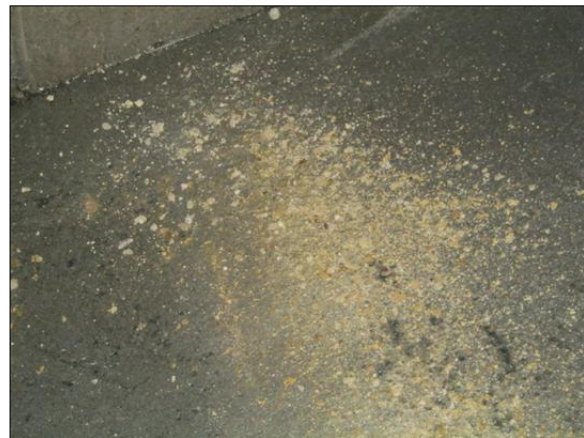
Photo 14. Minor erosion corrosion on floor of flow channel.

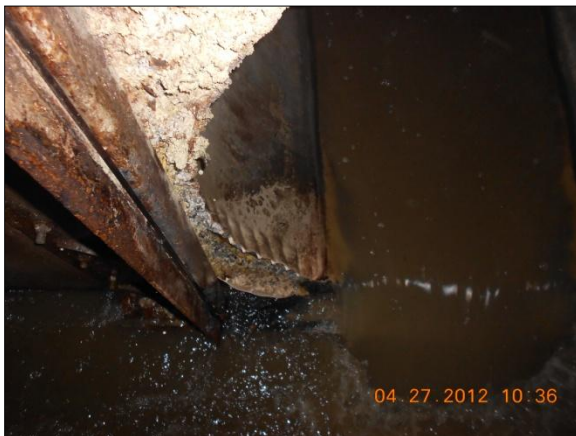
Photo 15. Concrete deterioration around south inlet penetration and T-Lock liner peeling on inlet pipe.

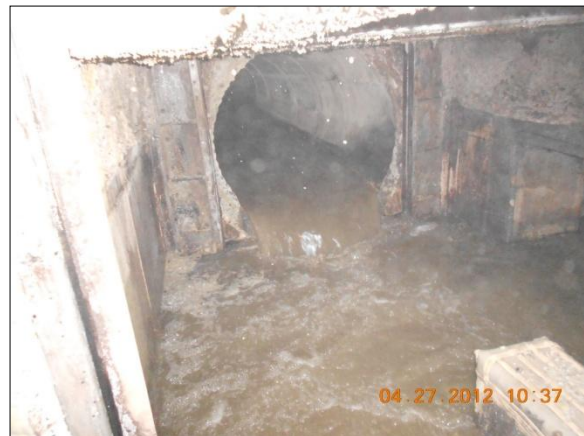
Photo 16. Concrete deterioration around west inlet penetration.

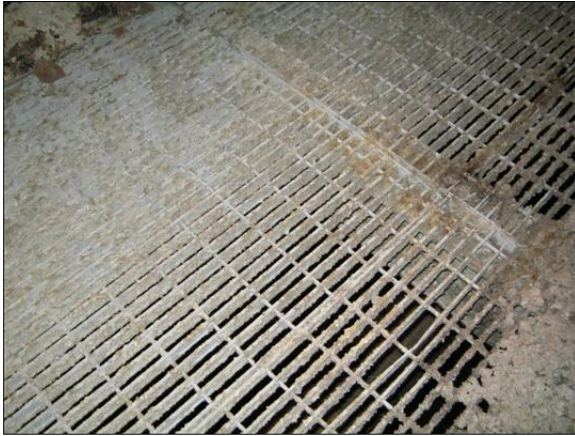
Photo 17. Aluminum grating in fair condition in most places.

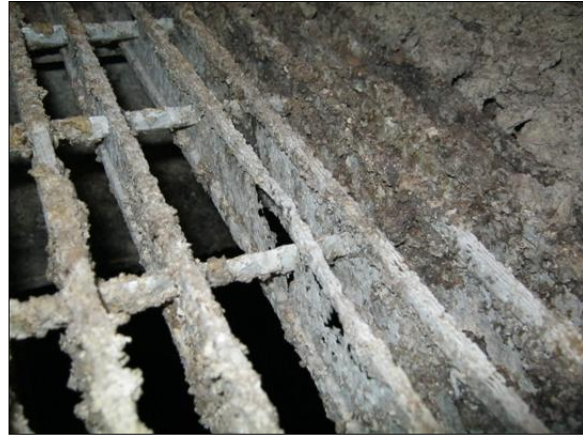
Photo 18. Small holes and perforations in thin members of grating.

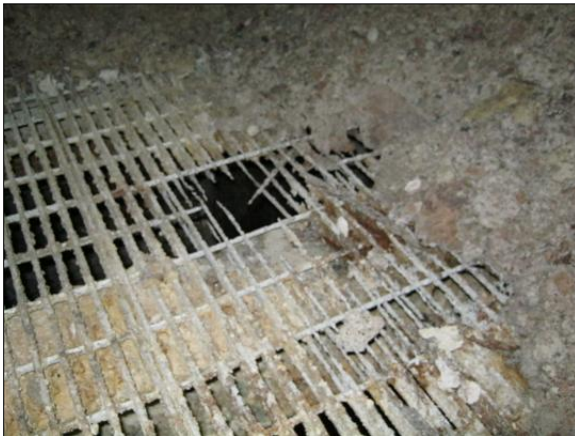
Photo 19. Patch of grating beneath HVAC ducting corroded through.

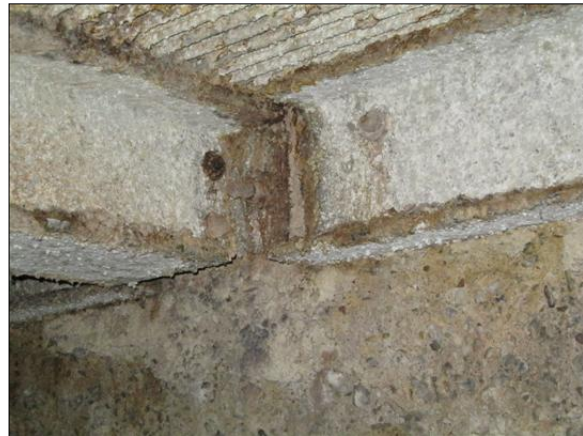
Photo 20. Aluminum beams and rafters covered with aluminum oxide but still sound.

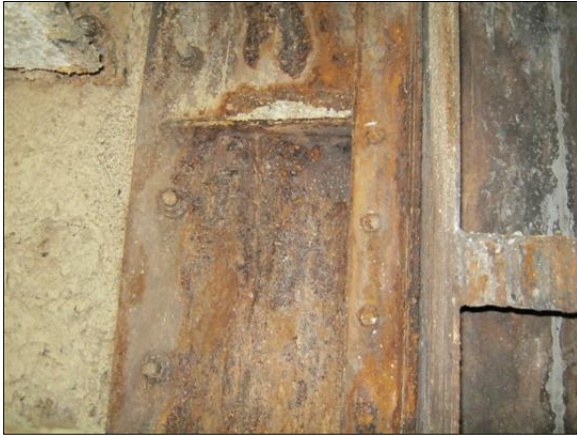
Photo 21. Surface corrosion and pitting on south sluice gate mounting/guide plate.

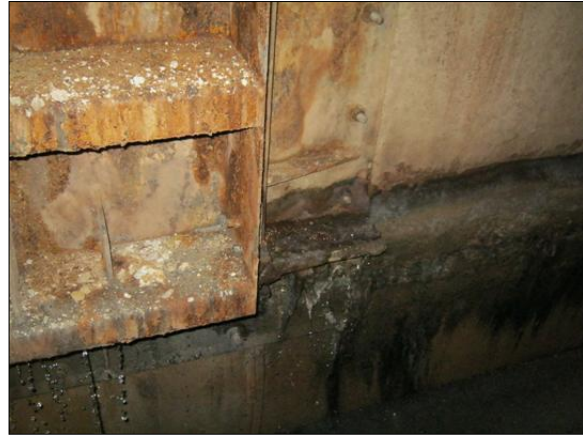
Photo 22. Surface corrosion and pitting on south sluice gate.

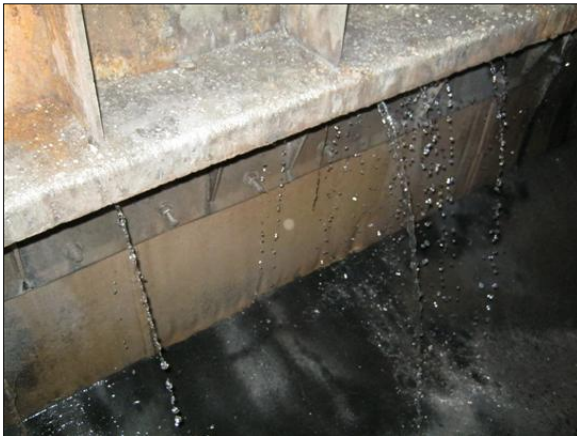
Photo 23. South sluice gate leaking approximately 2 to 5 gpm.

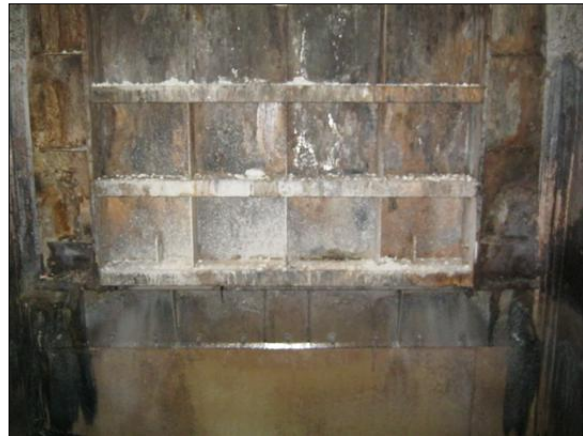
Photo 24. West sluice gate with corrosion similar to south sluice gate.

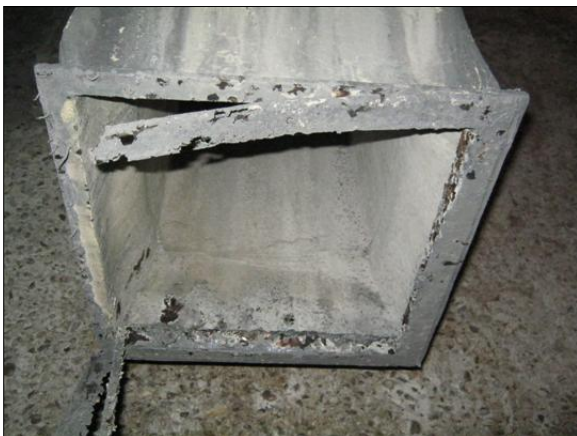
Photo 25. Screen to HVAC ducting missing.

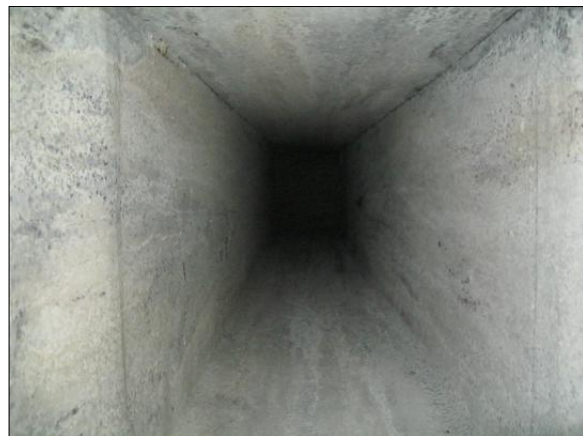
Photo 26. HVAC ducting appears to be open.

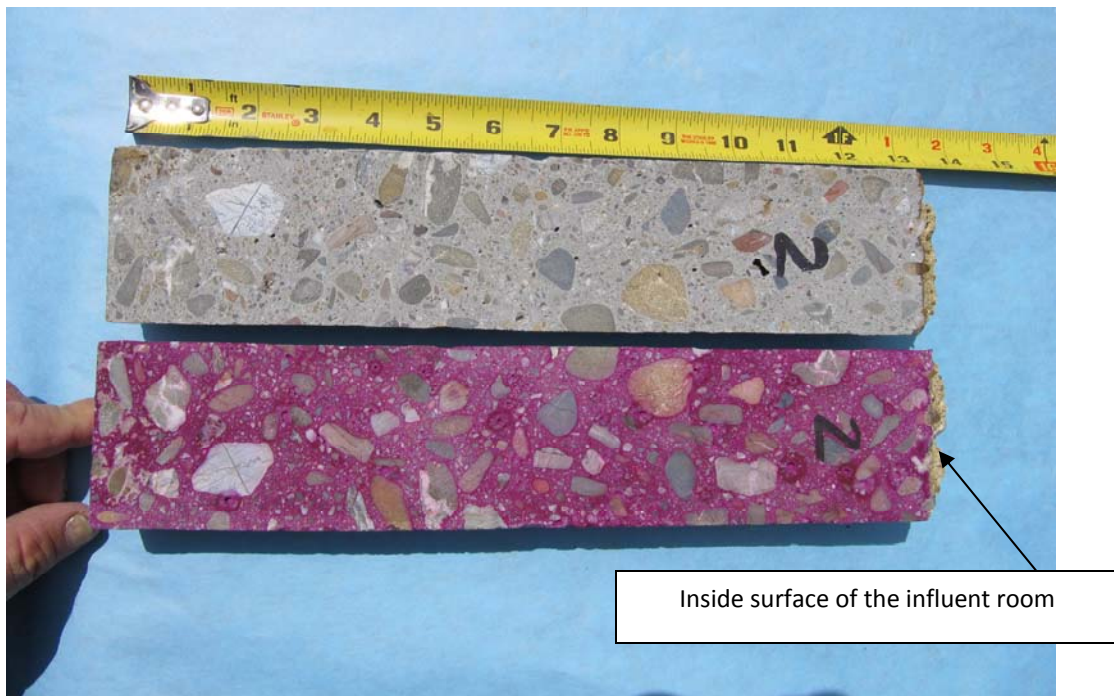
Photo 2) Macro-section prepared from roof slab core 2. The lower half of the core was stained with pH indicator (phenolphthalein). There is 13 inches of sound concrete in the roof slab at this location.

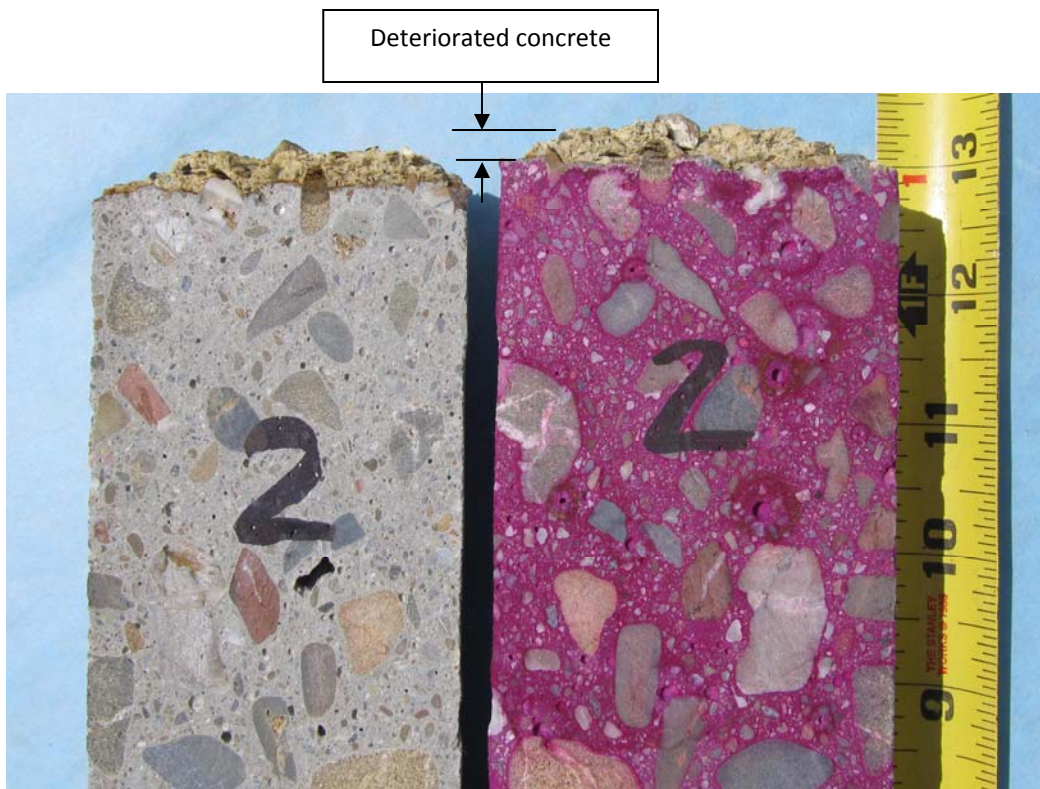
Photo 3) Close-up of Photo 2.

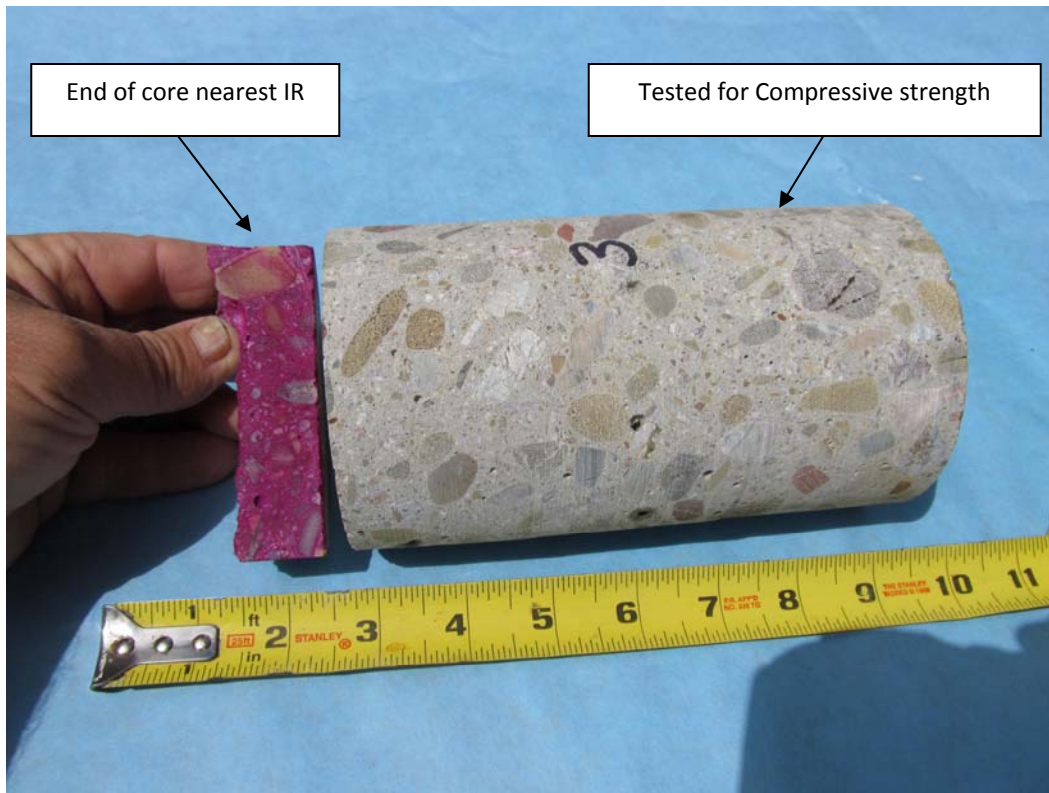
Photo 4) Wall core 3 was cut/trimmed as shown and the portion nearest the IR was stained with pH indicator solution (phenolphthalein). There is sound concrete to the 20¼" drilled depth of the core.

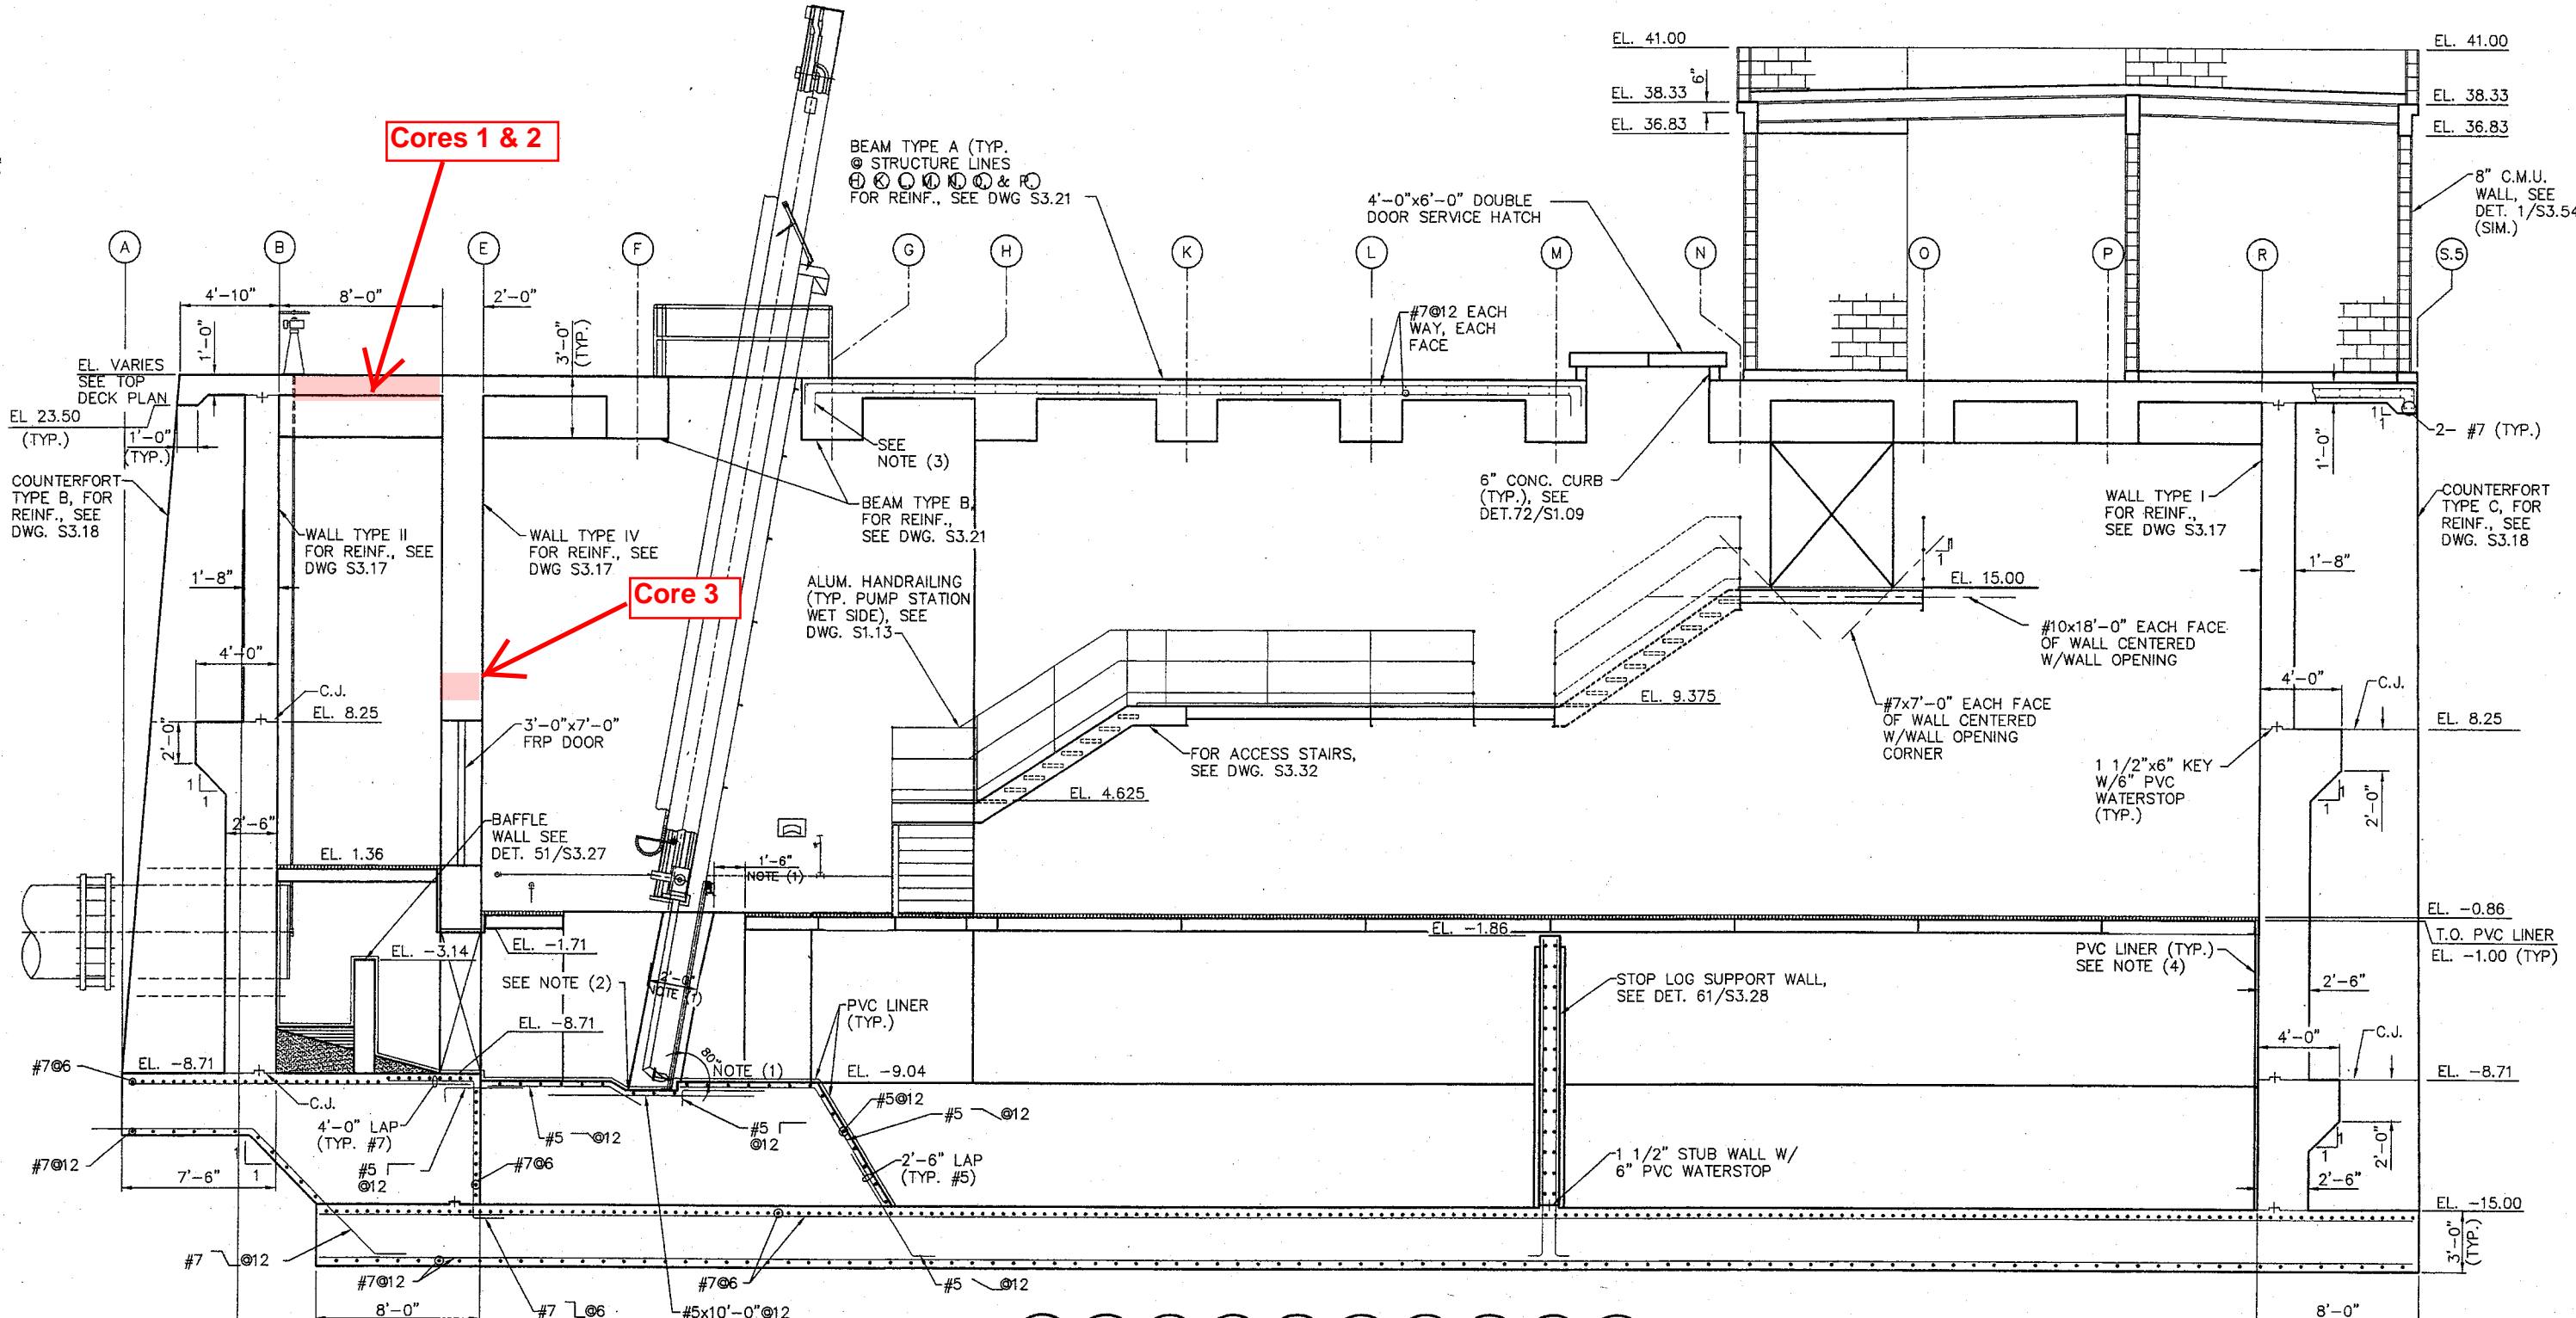
- NOTES:**
- (1) WALL RECESS FOR MECHANICAL BAR SCREEN. VERIFY LAYOUT DIMENSIONS WITH EQUIPMENT MANUFACTURER. SEE DET. 59/S3.27 FOR REINF. AROUND RECESS.
 - (2) PROVIDE SLAB RECESS PER MANUFACTURER REQUIREMENTS.
 - (3) TERMINATE TOP DECK REINF. WITH STANDARD HOOKS AT OPENINGS IN TOP DECK AND AT DECK EDGE (TYP.)
 - (4) PROVIDE PVC LINER ON WALLS OF PUMP STATION WET SIDE FROM INVERT TO EL. -1.00. ALSO PROVIDE PVC LINER ON FILLET SLOPES AND INVERTS AS SHOWN. FOR LINER DETAILS SEE DET.70/S1.09
